Access Compliance Report

Public Rights-of-Way

(Curb Ramps)

Intersection ID: 12721		Main Street: S_CHURCH_ST		Cross Street: W_HILL_ST		Location: E											
ADA ID: DA89158EF387		Ramp Type: Directional1		Initial Pass/Fail: Fail		Overall Compliance: No		Severity Score: 12.5									
Codes/Mitigation Info/Possible Solution				Field Measurements/Component Compliance													
<div>

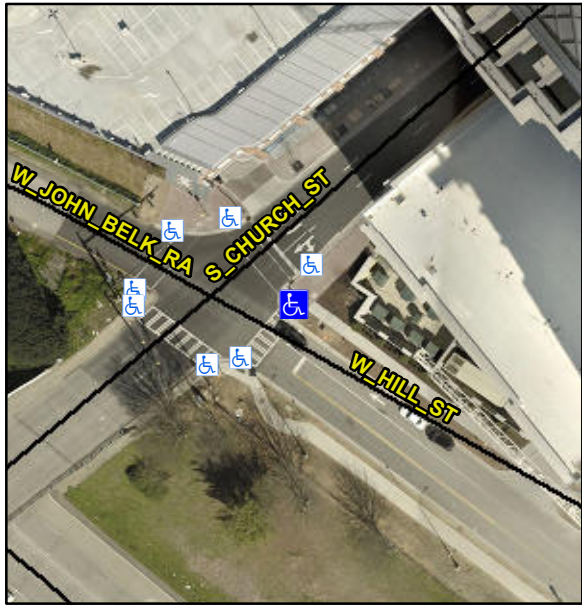
</div> <div>Possible Solutions:</div> <div>Remove & Replace Entire Ramp.</div> <div>Surveyor Notes:</div> <div>N/A</div> <div>PROW/ADA:</div> <div>R304.2.2</div> <div>Street 1 Name</div> <div>W HILL ST</div> <div>Stop Condition-Street 1</div> <div>Signal</div> <div>Street 2 Name</div> <div>N/A</div> <div>Stop Condition-Street 2</div> <div>N/A</div> <div>Total Cost:</div> <div>\$</div> <div>1600.00</div>				Compliance		Description		Data		Compliance		Description		Data			
				N/A		Ramp Length (in)		87.0		N/A		Grade Break?		N/A			
				Yes		Ramp Width (in)		59.0		N/A		Grade Break Slope (%)		0.0

No		Ramp Slope (%)		9.0		N/A		Grade Break XSlope (%)		0.0			
				Yes		Ramp XSlope (%)		1.0									
				N/A		Flare Type LT		N/A		N/A		Flare Type RT		N/A			
				N/A		Flare Slope LT (%)		N/A		N/A		Flare Slope RT (%)		0.0			
				N/A		Flare Traversable LT?		N/A		N/A		Flare Traversable RT?		N/A			
				N/A		Landing Length (in)		0.0		N/A		DWS Provided?		N/A			
				N/A		Landing Width (in)		0.0		N/A		DWS Contrast?		N/A			
				N/A		Landing Slope (%)		0.0		N/A		DWS Length (in)		N/A			
				N/A		Landing X Slope (%)		0.0		N/A		DWS Full Width?		N/A			
				N/A		Landing Curb? (Y/N)		N/A		N/A		DWS Offset LT (in)		N/A			
				N/A		Shared Landing?		N/A		N/A		DWS Offset RT (in)		N/A			
				N/A		Gutter Ponding?		0.0		N/A		Gutter Slope (%)		N/A			
				N/A		Gutter Lip Ht (in)		0.0		N/A		Gutter X Slope (%)		N/A			
				N/A		Painted X Walk1?		Yes				Road Slope (%)		1.1			
						X Walk 1 Direction		To SW				Road X Slope (%)		3.9

X Walk 1 Width (in)		111.0				Clear Space?		N/A			
						X Walk 1 Slope (%)		1.1		N/A		Clear Space to XWalk (in)		N/A			
						X Walk 1 X Slope (%)		3.9		N/A		Storm Grate/Utility Hazard?		N/A			
				N/A		Ramp inside XWalk1?		Yes				Storm Grate/Utility Type					
				N/A		Any Obstructions?		N/A						N/A			
						Obstruction Type				Yes		Surface Condition? (G/P)		Good			
										N/A		N/A		Curb Slope (%)		4.2
