Access Compliance Report Public Rights-of-Way (Curb Ramps)

Intersection ID: 16187 Main Street: LANIER_AV Cross Street: LYNNVILLE_AV Location: SE

ADA ID: DA936A06A309 Ramp Type: Directional1 Initial Pass/Fail: Fail Overall Compliance: No Severity Score: 25

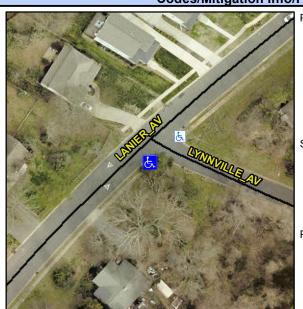
R304.5.3

Compliance Description Data		Compliance Description		Data	
N/A	Ramp Length (in)	37.0	N/A	N/A Grade Break?	
Yes	Ramp Width (in)	49.0	N/A	Grade Break Slope (%) 0.0
Yes	Ramp Slope (%)	4.9	N/A	Grade Break XSlope	(%) 0.0
No	Ramp XSlope (%)	10.9			
N/A	Flare Type LT	N/A	N/A	Flare Type RT	N/A
N/A	Flare Slope LT (%)	N/A	N/A	Flare Slope RT (%)	0.0
N/A	Flare Traversable LT?	N/A	N/A	Flare Traversable R	r? N/A
N/A	Landing Length (in)	0.0	N/A	DWS Provided?	N/A
N/A	Landing Width (in)	0.0	N/A	DWS Contrast?	N/A
N/A	Landing Slope (%)	0.0	N/A	DWS Length (in)	N/A
N/A	Landing X Slope (%)	0.0	N/A	DWS Full Width?	N/A
N/A	Landing Curb? (Y/N)	N/A	N/A	DWS Offset LT (in)	N/A
N/A	Shared Landing?	N/A	N/A	DWS Offset RT (in)	N/A
N/A	Gutter Ponding?	0.0	N/A	Gutter Slope (%)	N/A
N/A	Gutter Lip Ht (in)	0.0	N/A	Gutter X Slope (%)	N/A
N/A	Painted X Walk1?	No		Road Slope (%)	0.0
	X Walk 1 Direction	To NE		Road X Slope (%)	1.7
	X Walk 1 Width (in)	N/A		Clear Space?	N/A

X Walk 1 Slope (%)	0.0	N/A	Clear Space to XWa	lk (in) N/A
	X Walk 1 X Slope (%)	1.7	N/A	Storm Grate/Utility H	azard? N/A
N/A	Ramp inside XWalk1?	N/A		Storm Grate/Utility T	уре
N/A	Any Obstructions?	N/A			N/A
	Obstruction Type		Yes	Surface Condition? (G/P) Good
		N/A	N/A	Curb Slope (%)	15.4

Remove & Replace Entire Ramp.
