Access Compliance Report

Public Rights-of-Way

(Curb Ramps)

Intersection ID: 48312	Main Street: ROCKY_BROOK_CT	Cross Street: TRILLIUM_FIELDS_DR	Location: SW
ADA ID: DA9486AB8F64	Ramp Type: BlendTrans1	Initial Pass/Fail: Fail	Overall Compliance: No
		Severity Score: 10

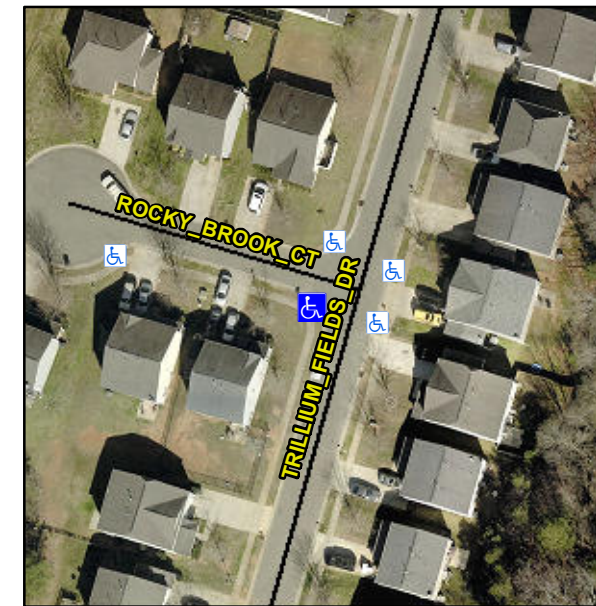
Compliance	Description	Data	Compliance	Description	Data
N/A	Ramp Length (in)	48.0	Yes	BlendTrans Slope (%)	4.9
No	Ramp Width (in)	45.0	No	BlendTrans XSlope (%)	4.5
N/A	Flare Type LT	N/A	N/A	Flare Type RT	N/A
N/A	Flare Slope LT (%)	N/A	N/A	Flare Slope RT (%)	N/A
N/A	Flare Traversable LT?	N/A	N/A	Flare Traversable RT?	N/A
N/A	Landing Length (in)	N/A	N/A	DWS Provided?	N/A
N/A	Landing Width (in)	N/A	N/A	DWS Contrast?	N/A
N/A	Landing Slope (%)	N/A	N/A	DWS Length (in)	N/A
N/A	Landing X Slope (%)	N/A	N/A	DWS Full Width?	N/A
N/A	Landing Curb? (Y/N)	N/A	N/A	DWS Offset (in)	N/A
N/A	Shared Landing?	N/A			
N/A	Gutter Ponding?	N/A	N/A	Gutter Slope (%)	N/A
N/A	Gutter Lip Ht (in)	N/A	N/A	Gutter X Slope (%)	N/A
N/A	Painted X Walk1?	No	N/A	Painted X Walk2?	No
	X Walk 1 Direction	To E		X Walk 2 Direction	To N
	X Walk 1 Width (in)	N/A		X Walk 2 Width (in)	N/A
	X Walk 1 Slope (%)	0.0		X Walk 2 Slope (%)	2.3
	X Walk 1 X Slope (%)	4.9		X Walk 2 X Slope (%)	0.5

N/A	Ramp inside XWalk1?	N/A	N/A	Ramp inside XWalk2?	N/A
	Road Slope (%)	3.4		Clear Space?	N/A
	Road X Slope (%)	2.4	N/A	Clear Space to XWalk (in)	N/A
N/A	Any Obstructions?	N/A	N/A	Storm Grate/Utility Hazard?	N/A
	Obstruction Type			Storm Grate/Utility Type	
		N/A			N/A
			Yes	Surface Condition? (G/P)	Good
			No	Curb Slope (%)	13.0

Possible Solutions:

Remove & Replace Curb Ramp With Two New Directional Ramps or Equivalent.
