Access Compliance Report

Public Rights-of-Way

(Curb Ramps)

Intersection ID: 3194	Main Street: HIGHCROFT_LN	Cross Street: OLD_BRIDGE_LN	Location: SW
ADA ID: DA9A11B0276E	Ramp Type: Perp	Initial Pass/Fail: Fail	Overall Compliance: No
Severity Score: 12.5			
Codes/Mitigation Info/Possible Solution		Field Measurements/Component Compliance

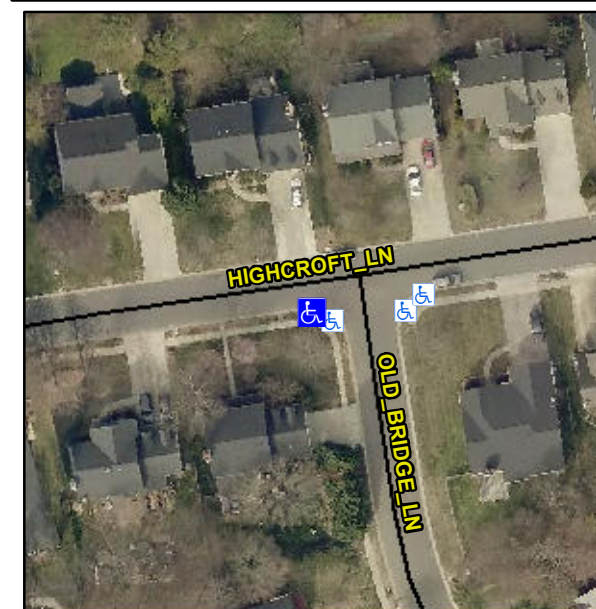
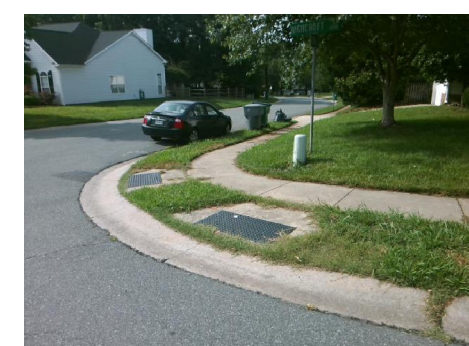
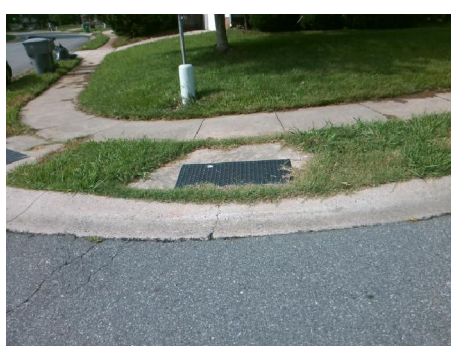
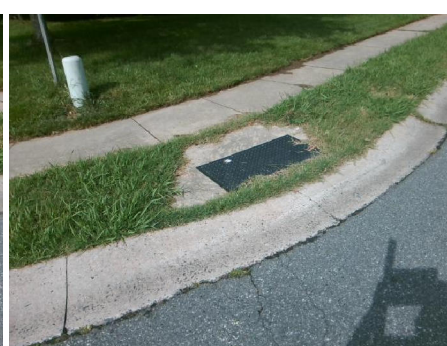
Not Found, R304.5.3

Compliance	Description	Data	Compliance	Description	Data
N/A	Ramp Length (in)	48.0	Yes	Ramp Slope (%)	5.5
Yes	Ramp Width (in)	48.0	No	Ramp XSlope (%)	6.1
N/A	Flare Type LT	N/A	N/A	Flare Type RT	N/A
N/A	Flare Slope LT (%)	N/A	N/A	Flare Slope RT (%)	N/A
N/A	Flare Traversable LT?	N/A	N/A	Flare Traversable RT?	N/A
N/A	Landing Length (in)	N/A	N/A	DWS Provided?	N/A
N/A	Landing Width (in)	N/A	N/A	DWS Contrast?	N/A
N/A	Landing Slope (%)	N/A	N/A	DWS Length (in)	N/A
N/A	Landing X Slope (%)	N/A	N/A	DWS Full Width?	N/A
N/A	Landing Curb? (Y/N)	N/A	N/A	DWS Offset (in)	N/A
N/A	Shared Landing?	N/A			
N/A	Gutter Ponding?	N/A	N/A	Gutter Slope (%)	N/A
N/A	Gutter Lip Ht (in)	N/A	N/A	Gutter X Slope (%)	N/A
N/A	Painted X Walk1?	No	N/A	Painted X Walk2?	N/A
	X Walk 1 Direction	To N		X Walk 2 Direction	N/A
N/A	X Walk 1 Width (in)	N/A	N/A	X Walk 2 Width (in)	N/A
	X Walk 1 Slope (%)	6.6		X Walk 2 Slope (%)	N/A
	X Walk 1 X Slope (%)	2.3		X Walk 2 X Slope (%)	N/A

N/A	Ramp inside XWalk1?	N/A	N/A	Ramp inside XWalk2?	N/A
	Road Slope (%)	N/A	N/A	Clear Space?	N/A
	Road X Slope (%)	N/A	N/A	Clear Space to XWalk (in)	N/A
N/A	Any Obstructions?	N/A	N/A	Storm Grate/Utility Hazard?	N/A
	Obstruction Type			Storm Grate/Utility Type	
		N/A			N/A
		Yes		Surface Condition? (G/P)	Good

Remove & Replace Entire Ramp.

Total Cost: \$ 1850.00
