Access Compliance Report

Public Rights-of-Way

(Curb Ramps)

Intersection ID: 13872	Main Street: S_TRYON_ST	Cross Street: W_WORTHINGTON_AV	Location: W
ADA ID: DAA085A26496	Ramp Type: Perp	Initial Pass/Fail: Fail	Overall Compliance: No
		Severity Score: 12.5

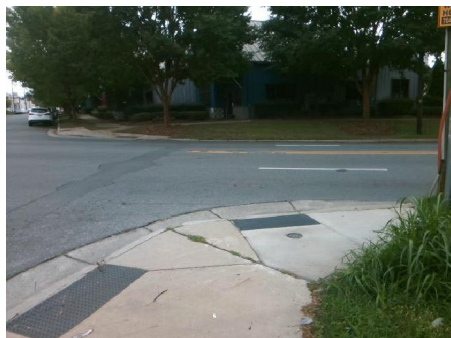
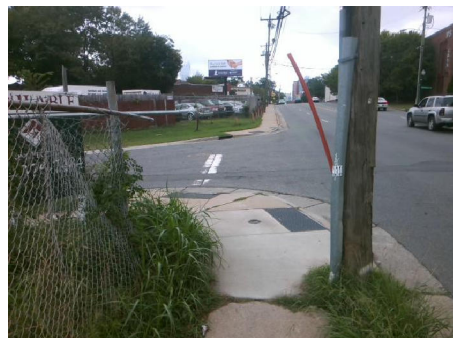
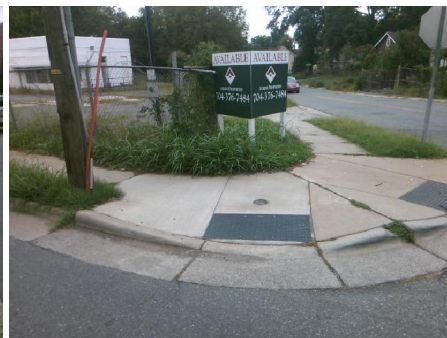
Compliance	Description	Data	Compliance	Description	Data
N/A	Ramp Length (in)	92.0	Yes	Ramp Slope (%)	6.1
Yes	Ramp Width (in)	48.0	No	Ramp XSlope (%)	5.3
N/A	Flare Type LT	N/A	N/A	Flare Type RT	N/A
N/A	Flare Slope LT (%)	N/A	N/A	Flare Slope RT (%)	N/A
N/A	Flare Traversable LT?	N/A	N/A	Flare Traversable RT?	N/A
N/A	Landing Length (in)	N/A	N/A	DWS Provided?	N/A
N/A	Landing Width (in)	N/A	N/A	DWS Contrast?	N/A
N/A	Landing Slope (%)	N/A	N/A	DWS Length (in)	N/A
N/A	Landing X Slope (%)	N/A	N/A	DWS Full Width?	N/A
N/A	Landing Curb? (Y/N)	N/A	N/A	DWS Offset (in)	N/A
N/A	Shared Landing?	N/A			
N/A	Gutter Ponding?	N/A	N/A	Gutter Slope (%)	N/A
N/A	Gutter Lip Ht (in)	N/A	N/A	Gutter X Slope (%)	N/A
N/A	Painted X Walk1?	No	N/A	Painted X Walk2?	N/A
	X Walk 1 Direction	To SE		X Walk 2 Direction	N/A
N/A	X Walk 1 Width (in)	N/A	N/A	X Walk 2 Width (in)	N/A
	X Walk 1 Slope (%)	5.3		X Walk 2 Slope (%)	N/A
	X Walk 1 X Slope (%)	0.4		X Walk 2 X Slope (%)	N/A

N/A	Ramp inside XWalk1?	N/A	N/A	Ramp inside XWalk2?	N/A
	Road Slope (%)	N/A	N/A	Clear Space?	N/A
	Road X Slope (%)	N/A	N/A	Clear Space to XWalk (in)	N/A
N/A	Any Obstructions?	N/A	N/A	Storm Grate/Utility Hazard?	N/A
	Obstruction Type			Storm Grate/Utility Type	
		N/A			N/A
			Yes	Surface Condition? (G/P)	Good

Remove & Replace Entire Ramp.
