Access Compliance Report

Public Rights-of-Way

(Curb Ramps)

Intersection ID: 17324	Main Street: KENSAL_CT	Cross Street: PROVIDENCE_RD	Location: SE
ADA ID: DAAF99319D79	Ramp Type: Perp	Initial Pass/Fail: Fail	Overall Compliance: No
		Severity Score: 22.5	
Codes/Mitigation Info/Possible Solution		Field Measurements/Component Compliance

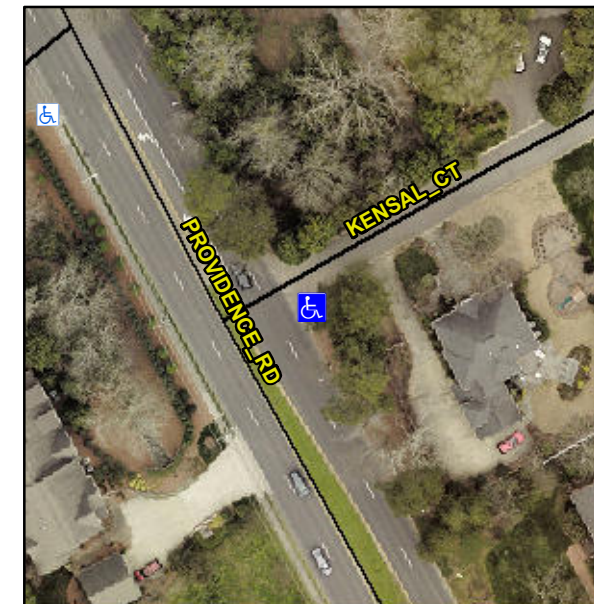
Not Found, R304.5.1, R304.2.2, R304.5.3

Compliance	Description	Data	Compliance	Description	Data
N/A	Ramp Length (in)	54.0	No	Ramp Slope (%)	8.9
No	Ramp Width (in)	44.0	No	Ramp XSlope (%)	2.4
N/A	Flare Type LT	N/A	N/A	Flare Type RT	N/A
N/A	Flare Slope LT (%)	N/A	N/A	Flare Slope RT (%)	N/A
N/A	Flare Traversable LT?	N/A	N/A	Flare Traversable RT?	N/A
N/A	Landing Length (in)	N/A	N/A	DWS Provided?	N/A
N/A	Landing Width (in)	N/A	N/A	DWS Contrast?	N/A
N/A	Landing Slope (%)	N/A	N/A	DWS Length (in)	N/A
N/A	Landing X Slope (%)	N/A	N/A	DWS Full Width?	N/A
N/A	Landing Curb? (Y/N)	N/A	N/A	DWS Offset (in)	N/A
N/A	Shared Landing?	N/A			
N/A	Gutter Ponding?	N/A	N/A	Gutter Slope (%)	N/A
N/A	Gutter Lip Ht (in)	N/A	N/A	Gutter X Slope (%)	N/A
N/A	Painted X Walk1?	No	N/A	Painted X Walk2?	N/A
	X Walk 1 Direction	To NW		X Walk 2 Direction	N/A
N/A	X Walk 1 Width (in)	N/A	N/A	X Walk 2 Width (in)	N/A
	X Walk 1 Slope (%)	1.8		X Walk 2 Slope (%)	N/A
	X Walk 1 X Slope (%)	1.8		X Walk 2 X Slope (%)	N/A

N/A	Ramp inside XWalk1?	N/A	N/A	Ramp inside XWalk2?	N/A
	Road Slope (%)	N/A	N/A	Clear Space?	N/A
	Road X Slope (%)	N/A	N/A	Clear Space to XWalk (in)	N/A
N/A	Any Obstructions?	N/A	N/A	Storm Grate/Utility Hazard?	N/A
	Obstruction Type			Storm Grate/Utility Type	
		N/A			N/A
			Yes	Surface Condition? (G/P)	Good

Possible Solutions:

Remove & Replace Entire Ramp.
