Access Compliance Report

Public Rights-of-Way

(Curb Ramps)

| Intersection ID: 44470 | Main Street: COREY_COMMON_AV | Cross Street: NEWFIELD_ST | Location: W |

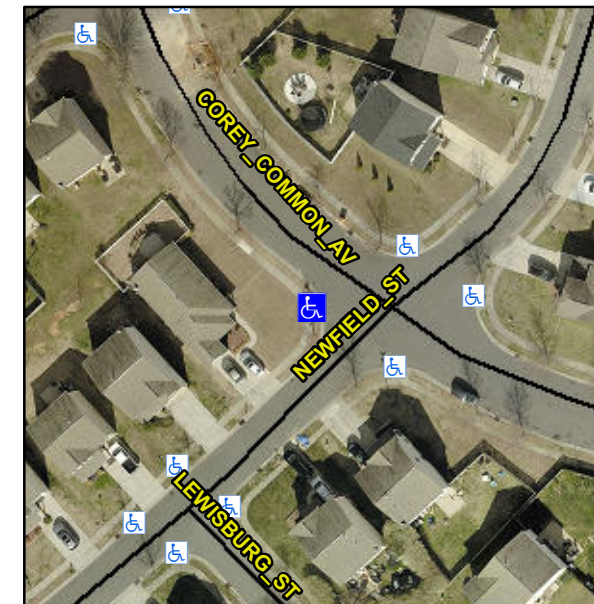
| ADA ID: DAB8032AB944 | Ramp Type: BlendTrans1 | Initial Pass/Fail: Fail | Overall Compliance: No |
| Severity Score: 8.75 | | | |

Not Found, R304.5.1

| Compliance | Description | Data | Compliance | Description | Data |
|---|---|---|---|---|---|
| No | Ramp Width (in) | 47.5 | Yes | BlendTrans XSlope (%) | 0.6 |
| | | | No | Curb Slope (%) | 14.2 |

Remove & Replace Curb Ramp With Two New Directional Ramps or Equivalent.
