Access Compliance Report

Public Rights-of-Way

(Curb Ramps)

Intersection ID: 8083	Main Street: CINDERELLA_RD	Cross Street: EDGERTON_DR	Location:	W
ADA ID: DABD14B10BBD	Ramp Type: Perp	Initial Pass/Fail: Fail	Overall Compliance: No	Severity Score: 10
Codes/Mitigation Info/Possible Solution		Field Measurements/Component Compliance

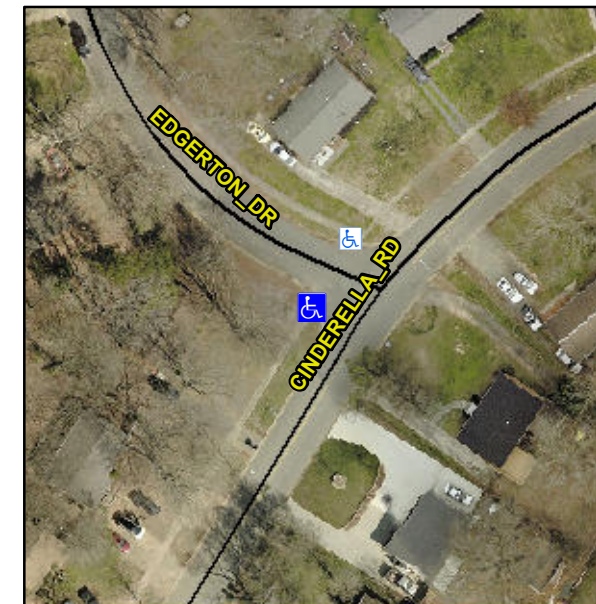
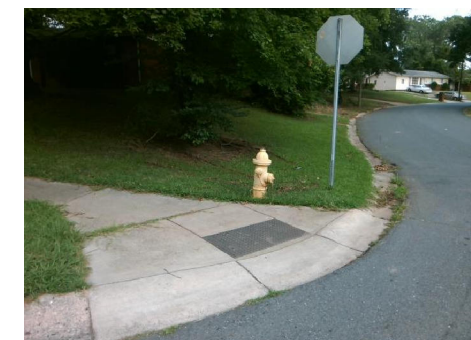
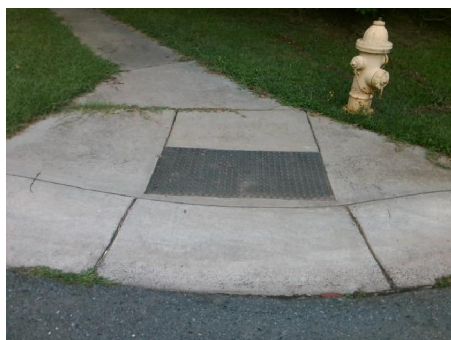
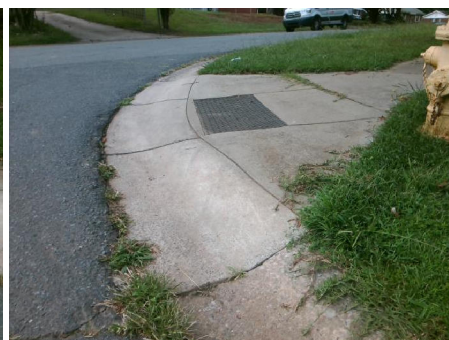
Not Found, R304.5.1, R304.5.3

Compliance	Description	Data	Compliance	Description	Data
N/A	Ramp Length (in)	58.5	Yes	Ramp Slope (%)	7.6
No	Ramp Width (in)	47.0	No	Ramp XSlope (%)	3.0
N/A	Flare Type LT	N/A	N/A	Flare Type RT	N/A
N/A	Flare Slope LT (%)	N/A	N/A	Flare Slope RT (%)	N/A
N/A	Flare Traversable LT?	N/A	N/A	Flare Traversable RT?	N/A
N/A	Landing Length (in)	N/A	N/A	DWS Provided?	N/A
N/A	Landing Width (in)	N/A	N/A	DWS Contrast?	N/A
N/A	Landing Slope (%)	N/A	N/A	DWS Length (in)	N/A
N/A	Landing X Slope (%)	N/A	N/A	DWS Full Width?	N/A
N/A	Landing Curb? (Y/N)	N/A	N/A	DWS Offset (in)	N/A
N/A	Shared Landing?	N/A			
N/A	Gutter Ponding?	N/A	N/A	Gutter Slope (%)	N/A
N/A	Gutter Lip Ht (in)	2.5	N/A	Gutter X Slope (%)	N/A
N/A	Painted X Walk1?	No	N/A	Painted X Walk2?	N/A
	X Walk 1 Direction	To NE		X Walk 2 Direction	N/A
N/A	X Walk 1 Width (in)	N/A	N/A	X Walk 2 Width (in)	N/A
	X Walk 1 Slope (%)	2.5		X Walk 2 Slope (%)	N/A
	X Walk 1 X Slope (%)	1.2		X Walk 2 X Slope (%)	N/A

N/A	Ramp inside XWalk1?	N/A	N/A	Ramp inside XWalk2?	N/A
	Road Slope (%)	N/A	N/A	Clear Space?	N/A
	Road X Slope (%)	N/A	N/A	Clear Space to XWalk (in)	N/A
N/A	Any Obstructions?	N/A	N/A	Storm Grate/Utility Hazard?	N/A
	Obstruction Type			Storm Grate/Utility Type	
		N/A			N/A
			Yes	Surface Condition? (G/P)	Good

Remove & Replace Entire Ramp.
