# Access Compliance Report

## Public Rights-of-Way

### (Curb Ramps)

Intersection ID: 9779	Main Street: CAMPUS_ST	Cross Street: CEMETERY_ST	Location: NW
ADA ID: DACF80E09673	Ramp Type: PerpDiag	Initial Pass/Fail: Fail	Overall Compliance: No
Codes/Mitigation Info/Possible Solution		Field Measurements/Component Compliance

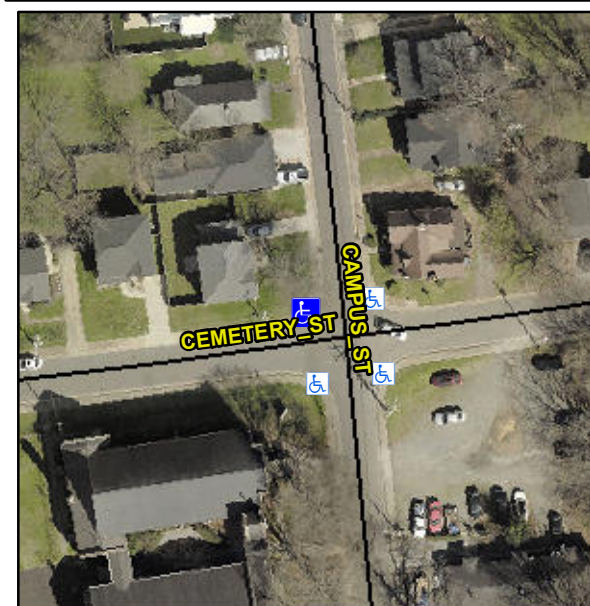
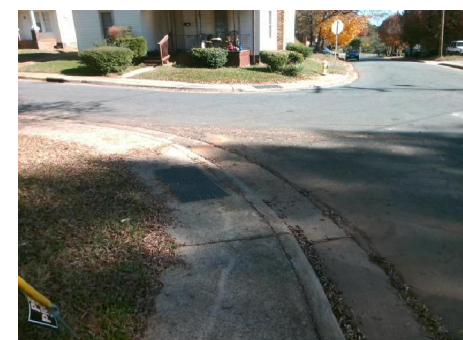
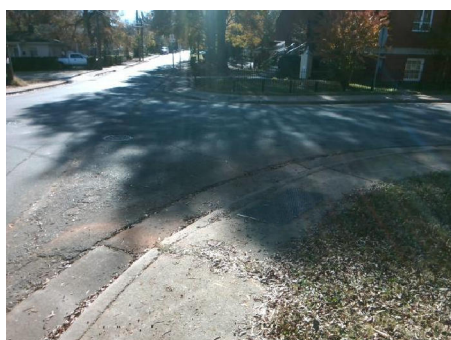
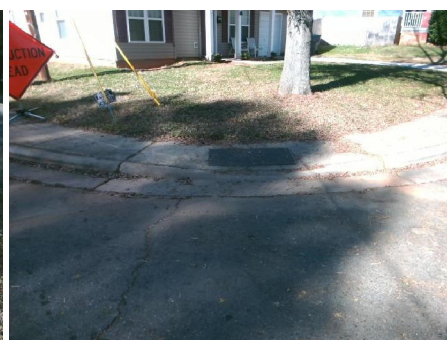
**Not Found, R304.5.1, R304.2.2**

Compliance	Description	Data	Compliance	Description	Data
N/A	Ramp Length (in)	48.0	No	Ramp Slope (%)	9.1
No	Ramp Width (in)	39.0	Yes	Ramp XSlope (%)	1.8
N/A	Flare Type LT	N/A	N/A	Flare Type RT	N/A
N/A	Flare Slope LT (%)	N/A	N/A	Flare Slope RT (%)	N/A
N/A	Flare Traversable LT?	N/A	N/A	Flare Traversable RT?	N/A
N/A	Landing Length (in)	N/A	N/A	DWS Provided?	N/A
N/A	Landing Width (in)	N/A	N/A	DWS Contrast?	N/A
N/A	Landing Slope (%)	N/A	N/A	DWS Length (in)	N/A
N/A	Landing X Slope (%)	N/A	N/A	DWS Full Width?	N/A
N/A	Landing Curb? (Y/N)	N/A	N/A	DWS Offset (in)	N/A
N/A	Shared Landing?	N/A			
N/A	Gutter Ponding?	Yes	N/A	Gutter Slope (%)	N/A
N/A	Gutter Lip Ht (in)	1.5	N/A	Gutter X Slope (%)	N/A
N/A	Painted X Walk1?	No	N/A	Painted X Walk2?	No
	X Walk 1 Direction	To S		X Walk 2 Direction	To E
N/A	X Walk 1 Width (in)	N/A	N/A	X Walk 2 Width (in)	N/A
	X Walk 1 Slope (%)	0.7		X Walk 2 Slope (%)	0.2
	X Walk 1 X Slope (%)	0.6		X Walk 2 X Slope (%)	1.6

N/A	Ramp inside XWalk1?	N/A	N/A	Ramp inside XWalk2?	N/A
	Road Slope (%)	0.8	N/A	Clear Space?	N/A
	Road X Slope (%)	0.5	N/A	Clear Space to XWalk (in)	N/A
N/A	Any Obstructions?	N/A	N/A	Storm Grate/Utility Hazard?	N/A
	Obstruction Type			Storm Grate/Utility Type	
		N/A			N/A
		Yes		Surface Condition? (G/P)	Good

**Remove & Replace Curb Ramp With Two New Directional Ramps or Equivalent.**

Total Cost: \$ **3200.00**
