Access Compliance Report Public Rights-of-Way (Curb Ramps)

Intersection ID: 14183 Main Street: WEST BV Cross Street: OLD_STEELE_CREEK_RD Location: NE **ADA ID: DACFFC071F05** Ramp Type: PerpDiag Initial Pass/Fail: Fail **Overall Compliance: No Severity Score:** 25

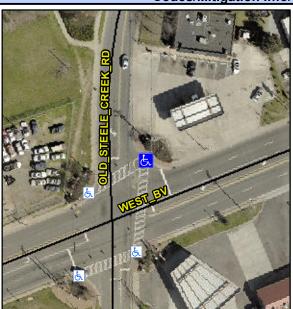
Field Measurements/Component Compliance						
Compliance Description		Data	Comp	liance	Description	Data
N/A	Ramp Length (in)	58.0	No	Ramp	Slope (%)	9.3
Yes	Ramp Width (in)	48.0	No	Ramp XSlope (%)		5.4
N/A	Flare Type LT	N/A	N/A	/A Flare Type RT		N/A
N/A	Flare Slope LT (%)	N/A	N/A	N/A Flare Slope RT (%)		N/A
N/A	Flare Traversable LT?	N/A	N/A	A Flare Traversable RT?		N/A
N/A	Landing Length (in)	N/A	N/A	DWS	Provided?	N/A
N/A	Landing Width (in)	N/A	N/A	DWS	Contrast?	N/A
N/A	Landing Slope (%)	N/A	N/A	DWS	Length (in)	N/A
N/A	Landing X Slope (%)	N/A	N/A	DWS	Full Width?	N/A
N/A	Landing Curb? (Y/N)	N/A	N/A	DWS	Offset (in)	N/A
N/A	Shared Landing?	N/A				
N/A	Gutter Ponding?	N/A	N/A	Gutte	Slope (%)	N/A
N/A	Gutter Lip Ht (in)	N/A	N/A	Gutte	X Slope (%)	N/A
N/A	Painted X Walk1?	Yes	N/A	Painte	ed X Walk2?	Yes
	X Walk 1 Direction	To W		X Wal	k 2 Direction	To S
N/A	X Walk 1 Width (in)	109.0	N/A	X Wal	k 2 Width (in)	103.0
	X Walk 1 Slope (%)	2.1		X Wal	k 2 Slope (%)	1.9

X Walk 1 X Slope (%)	2.6		X Wal	k 2 X Slope (%)	3.0
N/A	Ramp inside XWalk1?	Yes	N/A	Ramp	inside XWalk2?	Yes
	Road Slope (%)	3.8	N/A	Clear	Space?	N/A
	Road X Slope (%)	1.0	N/A	Clear	Space to XWalk (in)	N/A
N/A	Any Obstructions?	N/A	N/A	Storm	Grate/Utility Hazard?	N/A
	Obstruction Type			Storm	Grate/Utility Type	
		N/A				N/A
			Yes	Surfac	ce Condition? (G/P)	Good

Possible Solutions: Remove & Replace Curb Ramp With Two New Directional Ramps or Equivalent. Surveyor Notes: N/A PROW/ADA: Not Found, R304.2.2, R304.5.3
