Access Compliance Report

Public Rights-of-Way

(Curb Ramps)

| Intersection ID: 42769 | Main Street: ERWIN_RIDGE_AV | Cross Street: JEANETTE_CR | Location: | N |

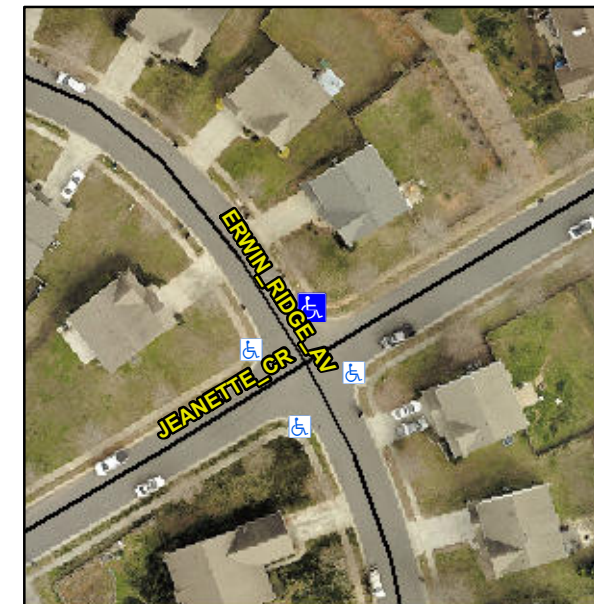
| ADA ID: DAD9D7E36BB4 | Ramp Type: PerpDiag | Initial Pass/Fail: Fail | Overall Compliance: No | Severity Score: 10 |

Not Found, R304.5.1, R304.5.3

| Compliance | Description | Data | Compliance | Description | Data |
|---|---|---|---|---|---|
| N/A | Ramp Length (in) | 47.0 | Yes | Ramp Slope (%) | 6.5 |
| No | Ramp Width (in) | 43.0 | No | Ramp XSlope (%) | 3.0 |

Remove & Replace Curb Ramp With Two New Directional Ramps or Equivalent.
