Access Compliance Report

Public Rights-of-Way

(Curb Ramps)

Intersection ID: 6174	Main Street: IRISH_MOSS_LN	Cross Street: MINTLEAF_DR	Location: S
ADA ID: DADBDEF7FC69	Ramp Type: Perp	Initial Pass/Fail: Fail	Overall Compliance: No
Severity Score: 10			
Codes/Mitigation Info/Possible Solution		Field Measurements/Component Compliance

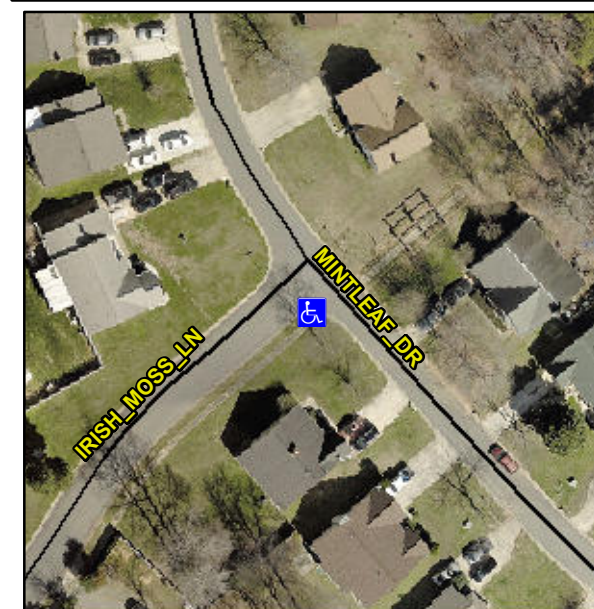
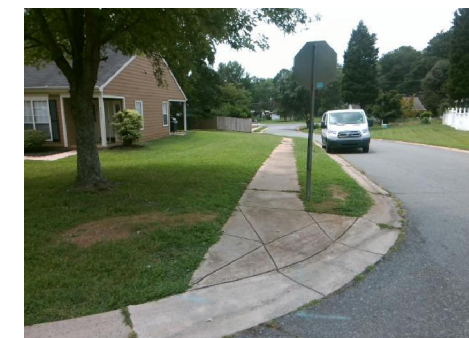
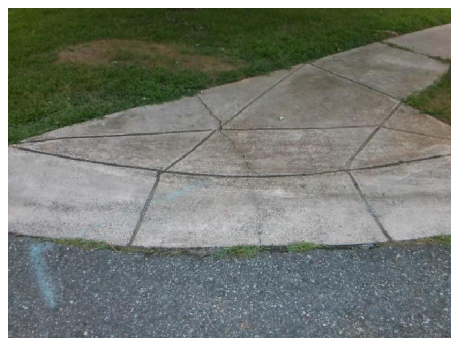
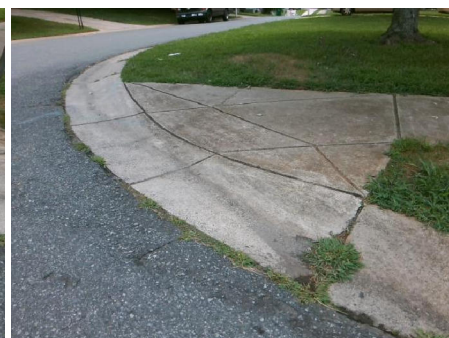
Compliance	Description	Data	Compliance	Description	Data
N/A	Ramp Length (in)	23.0	Yes	Ramp Slope (%)	7.8
No	Ramp Width (in)	46.0	No	Ramp XSlope (%)	3.6
N/A	Flare Type LT	N/A	N/A	Flare Type RT	N/A
N/A	Flare Slope LT (%)	N/A	N/A	Flare Slope RT (%)	N/A
N/A	Flare Traversable LT?	N/A	N/A	Flare Traversable RT?	N/A
N/A	Landing Length (in)	N/A	N/A	DWS Provided?	N/A
N/A	Landing Width (in)	N/A	N/A	DWS Contrast?	N/A
N/A	Landing Slope (%)	N/A	N/A	DWS Length (in)	N/A
N/A	Landing X Slope (%)	N/A	N/A	DWS Full Width?	N/A
N/A	Landing Curb? (Y/N)	N/A	N/A	DWS Offset (in)	N/A
N/A	Shared Landing?	N/A			
N/A	Gutter Ponding?	N/A	N/A	Gutter Slope (%)	N/A
N/A	Gutter Lip Ht (in)	0.5	N/A	Gutter X Slope (%)	N/A
N/A	Painted X Walk1?	No	N/A	Painted X Walk2?	N/A
	X Walk 1 Direction	To W		X Walk 2 Direction	N/A
N/A	X Walk 1 Width (in)	N/A	N/A	X Walk 2 Width (in)	N/A
	X Walk 1 Slope (%)	8.3		X Walk 2 Slope (%)	N/A
	X Walk 1 X Slope (%)	2.5		X Walk 2 X Slope (%)	N/A

N/A	Ramp inside XWalk1?	N/A	N/A	Ramp inside XWalk2?	N/A
	Road Slope (%)	N/A	N/A	Clear Space?	N/A
	Road X Slope (%)	N/A	N/A	Clear Space to XWalk (in)	N/A
N/A	Any Obstructions?	N/A	N/A	Storm Grate/Utility Hazard?	N/A
	Obstruction Type			Storm Grate/Utility Type	
		N/A			N/A
		Yes		Surface Condition? (G/P)	Good

Possible Solutions:

Remove & Replace Entire Ramp.

R304.5.1, R304.5.3
