Access Compliance Report

Public Rights-of-Way

(Curb Ramps)

Intersection ID: 15141	Main Street: IDEAL_WY	Cross Street: MARSHALL_PL	Location: N
ADA ID: DAE7799DE566	Ramp Type: Directional1	Initial Pass/Fail: Fail	Overall Compliance: No
		Severity Score: 12.5

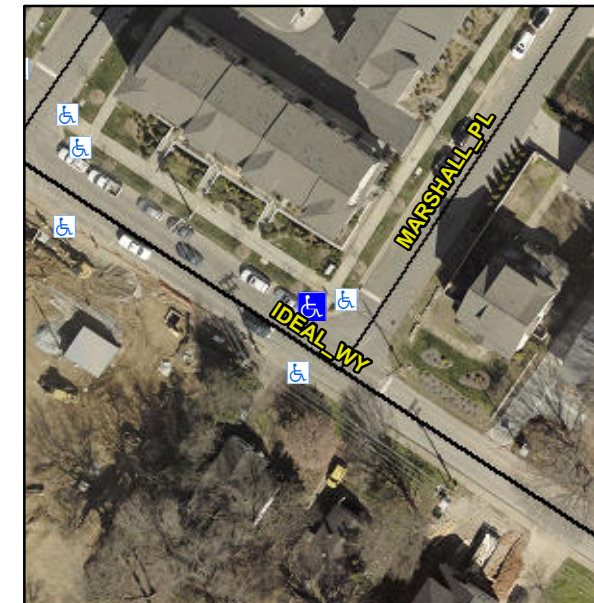
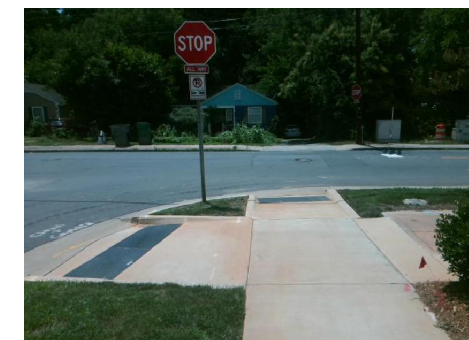
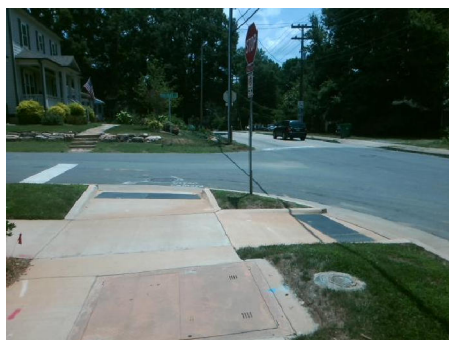
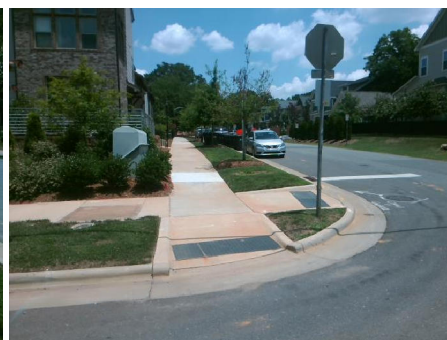
Compliance	Description	Data	Compliance	Description	Data
N/A	Ramp Length (in)	83.0	N/A	Grade Break?	N/A
Yes	Ramp Width (in)	67.0	N/A	Grade Break Slope (%)	0.0
No	Ramp Slope (%)	10.4	N/A	Grade Break XSlope (%)	0.0
Yes	Ramp XSlope (%)	1.5			
N/A	Flare Type LT	N/A	N/A	Flare Type RT	N/A
N/A	Flare Slope LT (%)	N/A	N/A	Flare Slope RT (%)	0.0
N/A	Flare Traversable LT?	N/A	N/A	Flare Traversable RT?	N/A
N/A	Landing Length (in)	0.0	N/A	DWS Provided?	N/A
N/A	Landing Width (in)	0.0	N/A	DWS Contrast?	N/A
N/A	Landing Slope (%)	0.0	N/A	DWS Length (in)	N/A
N/A	Landing X Slope (%)	0.0	N/A	DWS Full Width?	N/A
N/A	Landing Curb? (Y/N)	N/A	N/A	DWS Offset LT (in)	N/A
N/A	Shared Landing?	N/A	N/A	DWS Offset RT (in)	N/A
N/A	Gutter Ponding?	0.0	N/A	Gutter Slope (%)	N/A
N/A	Gutter Lip Ht (in)	0.0	N/A	Gutter X Slope (%)	N/A
N/A	Painted X Walk1?	No		Road Slope (%)	0.7
	X Walk 1 Direction	To SW		Road X Slope (%)	0.2
	X Walk 1 Width (in)	N/A		Clear Space?	N/A

X Walk 1 Slope (%)	0.7	N/A	Clear Space to XWalk (in)	N/A
	X Walk 1 X Slope (%)	0.2	N/A	Storm Grate/Utility Hazard?	N/A
N/A	Ramp inside XWalk1?	N/A		Storm Grate/Utility Type	
N/A	Any Obstructions?	N/A			N/A
	Obstruction Type		Yes	Surface Condition? (G/P)	Good
			N/A	Curb Slope (%)	9.5

Possible Solutions:

Remove & Replace Entire Ramp.
