Access Compliance Report

Public Rights-of-Way

(Curb Ramps)

Intersection ID: 48714	Main Street: SARDIS_CREEK_LN	Cross Street: KILCULLEN_DR	Location: W
ADA ID: DAF3D2FCAD25	Ramp Type: Perp	Initial Pass/Fail: Fail	Overall Compliance: No
Codes/Mitigation Info/Possible Solution		Field Measurements/Component Compliance	
Severity Score: 13.75

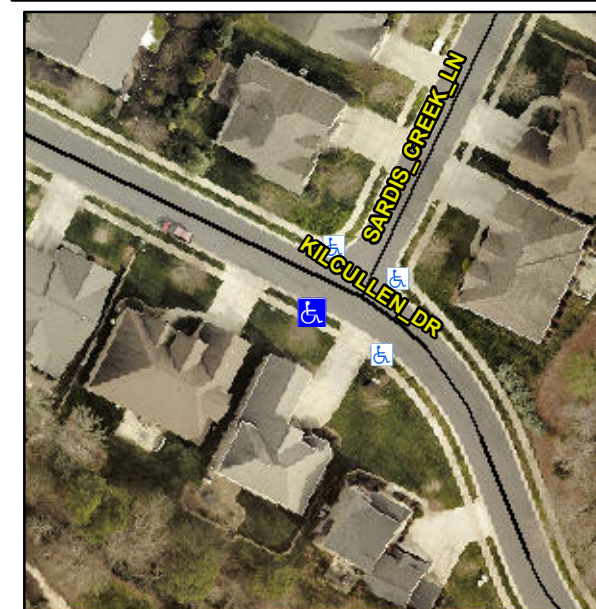
Compliance	Description	Data	Compliance	Description	Data
N/A	Ramp Length (in)	49.0	No	Ramp Slope (%)	9.0
Yes	Ramp Width (in)	48.0	Yes	Ramp XSlope (%)	3.5
N/A	Flare Type LT	N/A	N/A	Flare Type RT	N/A
N/A	Flare Slope LT (%)	N/A	N/A	Flare Slope RT (%)	N/A
N/A	Flare Traversable LT?	N/A	N/A	Flare Traversable RT?	N/A
N/A	Landing Length (in)	N/A	N/A	DWS Provided?	N/A
N/A	Landing Width (in)	N/A	N/A	DWS Contrast?	N/A
N/A	Landing Slope (%)	N/A	N/A	DWS Length (in)	N/A
N/A	Landing X Slope (%)	N/A	N/A	DWS Full Width?	N/A
N/A	Landing Curb? (Y/N)	N/A	N/A	DWS Offset (in)	N/A
N/A	Shared Landing?	N/A			
N/A	Gutter Ponding?	N/A	N/A	Gutter Slope (%)	N/A
N/A	Gutter Lip Ht (in)	N/A	N/A	Gutter X Slope (%)	N/A
N/A	Painted X Walk1?	No	N/A	Painted X Walk2?	N/A
	X Walk 1 Direction	To N		X Walk 2 Direction	N/A
N/A	X Walk 1 Width (in)	N/A	N/A	X Walk 2 Width (in)	N/A
	X Walk 1 Slope (%)	0.1		X Walk 2 Slope (%)	N/A
	X Walk 1 X Slope (%)	4.1		X Walk 2 X Slope (%)	N/A

N/A	Ramp inside XWalk1?	N/A	N/A	Ramp inside XWalk2?	N/A
	Road Slope (%)	N/A	N/A	Clear Space?	N/A
	Road X Slope (%)	N/A	N/A	Clear Space to XWalk (in)	N/A
N/A	Any Obstructions?	N/A	N/A	Storm Grate/Utility Hazard?	N/A
	Obstruction Type			Storm Grate/Utility Type	
		N/A			N/A
			Yes	Surface Condition? (G/P)	Good

Possible Solutions:

Remove & Replace Entire Ramp.

PROW/ADA:

R304.2.2
