Access Compliance Report

Public Rights-of-Way

(Curb Ramps)

Intersection ID: 14827	Main Street: PIERCE_ST	Cross Street: WAVERLY_AV	Location: W
ADA ID: DAFC82607EA0	Ramp Type: PerpDiag	Initial Pass/Fail: Fail	Overall Compliance: No
		Severity Score: 12.5

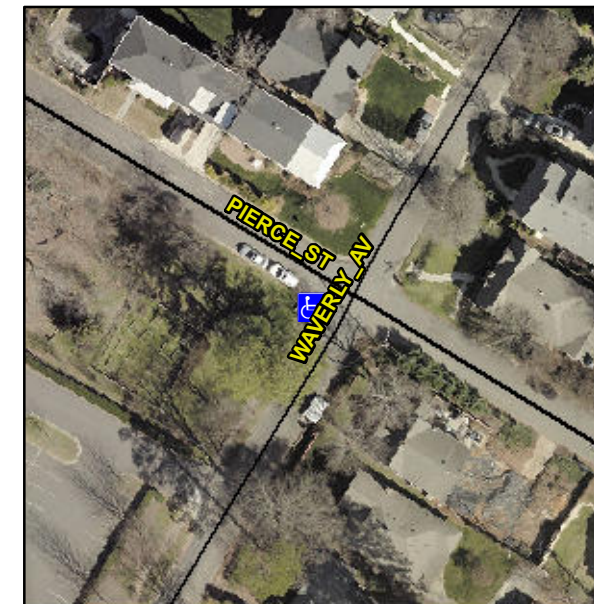
Not Found, R304.5.3

Compliance	Description	Data	Compliance	Description	Data
N/A	Ramp Length (in)	83.0	Yes	Ramp Slope (%)	8.2
Yes	Ramp Width (in)	48.0	No	Ramp XSlope (%)	5.3
N/A	Flare Type LT	N/A	N/A	Flare Type RT	N/A
N/A	Flare Slope LT (%)	N/A	N/A	Flare Slope RT (%)	N/A
N/A	Flare Traversable LT?	N/A	N/A	Flare Traversable RT?	N/A
N/A	Landing Length (in)	N/A	N/A	DWS Provided?	N/A
N/A	Landing Width (in)	N/A	N/A	DWS Contrast?	N/A
N/A	Landing Slope (%)	N/A	N/A	DWS Length (in)	N/A
N/A	Landing X Slope (%)	N/A	N/A	DWS Full Width?	N/A
N/A	Landing Curb? (Y/N)	N/A	N/A	DWS Offset (in)	N/A
N/A	Shared Landing?	N/A			
N/A	Gutter Ponding?	N/A	N/A	Gutter Slope (%)	N/A
N/A	Gutter Lip Ht (in)	N/A	N/A	Gutter X Slope (%)	N/A
N/A	Painted X Walk1?	No	N/A	Painted X Walk2?	No
	X Walk 1 Direction	To SE		X Walk 2 Direction	To NE
N/A	X Walk 1 Width (in)	N/A	N/A	X Walk 2 Width (in)	N/A
	X Walk 1 Slope (%)	2.0		X Walk 2 Slope (%)	0.9
	X Walk 1 X Slope (%)	2.6		X Walk 2 X Slope (%)	0.8

N/A	Ramp inside XWalk1?	N/A	N/A	Ramp inside XWalk2?	N/A
	Road Slope (%)	3.3	N/A	Clear Space?	N/A
	Road X Slope (%)	0.8	N/A	Clear Space to XWalk (in)	N/A
N/A	Any Obstructions?	N/A	N/A	Storm Grate/Utility Hazard?	N/A
	Obstruction Type			Storm Grate/Utility Type	
		N/A			N/A
			Yes	Surface Condition? (G/P)	Good

Remove & Replace Curb Ramp With Two New Directional Ramps or Equivalent.

Total Cost: \$ 3200.00
