# Access Compliance Report

## Public Rights-of-Way

### (Curb Ramps)

Intersection ID: 7606	Main Street: STARITA_RD	Cross Street: WOODPARK_BV	Location: SW
ADA ID: DAFFFA8D3650	Ramp Type: Perp	Initial Pass/Fail: Fail	Overall Compliance: No
			Severity Score: 50

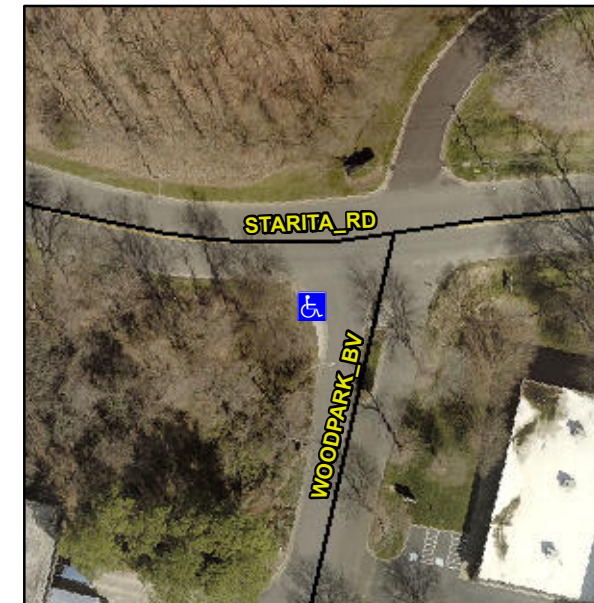
**Not Found, R304.2.2, R304.5.3**

Compliance	Description	Data	Compliance	Description	Data
N/A	Ramp Length (in)	38.0	No	Ramp Slope (%)	16.7
Yes	Ramp Width (in)	68.0	No	Ramp XSlope (%)	11.7
N/A	Flare Type LT	N/A	N/A	Flare Type RT	N/A
N/A	Flare Slope LT (%)	N/A	N/A	Flare Slope RT (%)	N/A
N/A	Flare Traversable LT?	N/A	N/A	Flare Traversable RT?	N/A
N/A	Landing Length (in)	N/A	N/A	DWS Provided?	N/A
N/A	Landing Width (in)	N/A	N/A	DWS Contrast?	N/A
N/A	Landing Slope (%)	N/A	N/A	DWS Length (in)	N/A
N/A	Landing X Slope (%)	N/A	N/A	DWS Full Width?	N/A
N/A	Landing Curb? (Y/N)	N/A	N/A	DWS Offset (in)	N/A
N/A	Shared Landing?	N/A			
N/A	Gutter Ponding?	N/A	N/A	Gutter Slope (%)	N/A
N/A	Gutter Lip Ht (in)	N/A	N/A	Gutter X Slope (%)	N/A
N/A	Painted X Walk1?	No	N/A	Painted X Walk2?	N/A
	X Walk 1 Direction	To NE		X Walk 2 Direction	N/A
N/A	X Walk 1 Width (in)	N/A	N/A	X Walk 2 Width (in)	N/A
	X Walk 1 Slope (%)	6.7		X Walk 2 Slope (%)	N/A
	X Walk 1 X Slope (%)	13.5		X Walk 2 X Slope (%)	N/A

N/A	Ramp inside XWalk1?	N/A	N/A	Ramp inside XWalk2?	N/A
	Road Slope (%)	N/A	N/A	Clear Space?	N/A
	Road X Slope (%)	N/A	N/A	Clear Space to XWalk (in)	N/A
N/A	Any Obstructions?	N/A	N/A	Storm Grate/Utility Hazard?	N/A
	Obstruction Type			Storm Grate/Utility Type	
		N/A			N/A
			Yes	Surface Condition? (G/P)	Good

**Remove & Replace Entire Ramp.**

Total Cost: \$ 1850.00
