Access Compliance Report

Public Rights-of-Way

(Curb Ramps)

Intersection ID: 44073	Main Street: WESTMILL_LN	Cross Street: SEDGEMOOR_LN	Location: E
ADA ID: DB0121F390A9	Ramp Type: BlendTrans1	Initial Pass/Fail: Fail	Overall Compliance: No
Severity Score: 35			
Codes/Mitigation Info/Possible Solution		Field Measurements/Component Compliance

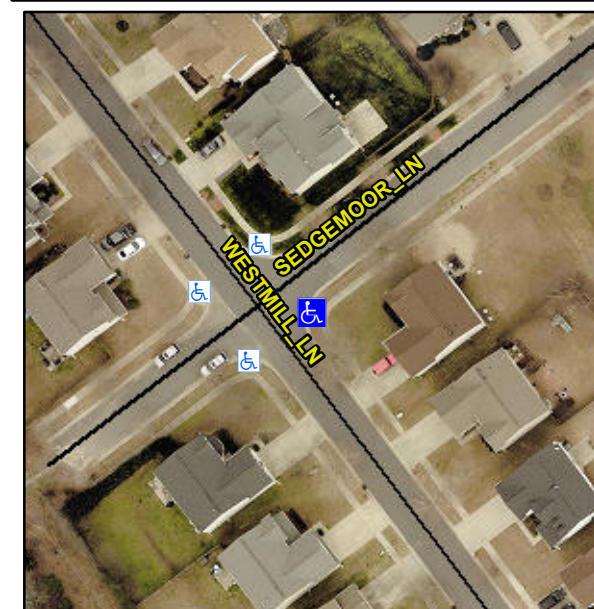
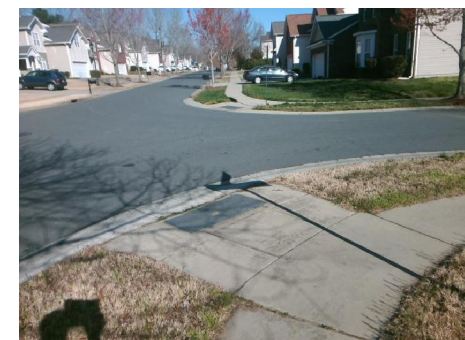
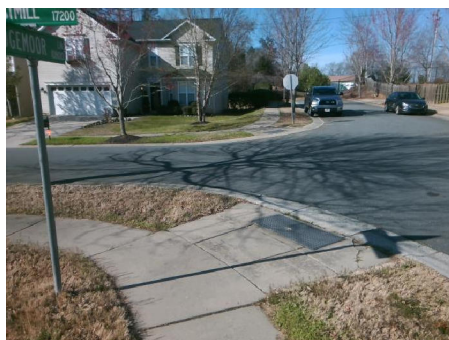
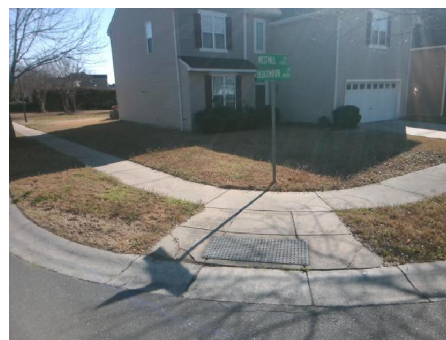
GTR GAP 2.0

R304.5.1

Compliance	Description	Data	Compliance	Description	Data
N/A	Ramp Length (in)	70.0	Yes	BlendTrans Slope (%)	2.0
No	Ramp Width (in)	31.5	Yes	BlendTrans XSlope (%)	1.0
N/A	Flare Type LT	N/A	N/A	Flare Type RT	N/A
N/A	Flare Slope LT (%)	N/A	N/A	Flare Slope RT (%)	N/A
N/A	Flare Traversable LT?	N/A	N/A	Flare Traversable RT?	N/A
N/A	Landing Length (in)	N/A	N/A	DWS Provided?	N/A
N/A	Landing Width (in)	N/A	N/A	DWS Contrast?	N/A
N/A	Landing Slope (%)	N/A	N/A	DWS Length (in)	N/A
N/A	Landing X Slope (%)	N/A	N/A	DWS Full Width?	N/A
N/A	Landing Curb? (Y/N)	N/A	N/A	DWS Offset (in)	N/A
N/A	Shared Landing?	N/A			
N/A	Gutter Ponding?	N/A	N/A	Gutter Slope (%)	N/A
N/A	Gutter Lip Ht (in)	N/A	N/A	Gutter X Slope (%)	N/A
N/A	Painted X Walk1?	No	N/A	Painted X Walk2?	No
	X Walk 1 Direction	To NW		X Walk 2 Direction	To SW
	X Walk 1 Width (in)	N/A		X Walk 2 Width (in)	N/A
	X Walk 1 Slope (%)	2.7		X Walk 2 Slope (%)	2.7
	X Walk 1 X Slope (%)	2.5		X Walk 2 X Slope (%)	2.4

N/A	Ramp inside XWalk1?	N/A	N/A	Ramp inside XWalk2?	N/A
	Road Slope (%)	2.8		Clear Space?	N/A
	Road X Slope (%)	3.7	N/A	Clear Space to XWalk (in)	N/A
N/A	Any Obstructions?	N/A	N/A	Storm Grate/Utility Hazard?	N/A
	Obstruction Type			Storm Grate/Utility Type	
		N/A			N/A
			Yes	Surface Condition? (G/P)	Good
			N/A	Curb Slope (%)	0.7

Remove & Replace Curb Ramp With Two New Directional Ramps or Equivalent.
