# Access Compliance Report

## Public Rights-of-Way

### (Curb Ramps)

Intersection ID: 42456	Main Street: SUNNINGHILL_PARK_RD	Cross Street: KINGSLEY_VIEW_DR	Location: SE
ADA ID: DB0A4126F915	Ramp Type: PerpDiag	Initial Pass/Fail: Fail	Overall Compliance: No
Codes/Mitigation Info/Possible Solution		Field Measurements/Component Compliance	
Severity Score: 25

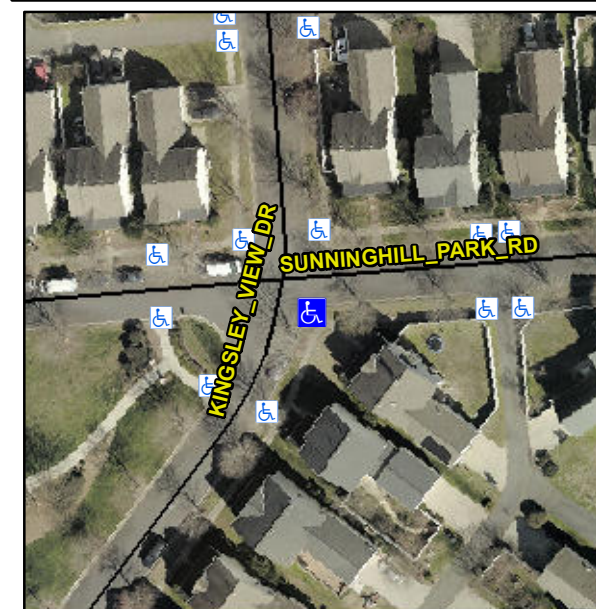
**R304.2.2, R304.5.3**

Compliance	Description	Data	Compliance	Description	Data
N/A	Ramp Length (in)	78.0	No	Ramp Slope (%)	10.3
Yes	Ramp Width (in)	48.0	No	Ramp XSlope (%)	6.5
N/A	Flare Type LT	N/A	N/A	Flare Type RT	N/A
N/A	Flare Slope LT (%)	N/A	N/A	Flare Slope RT (%)	N/A
N/A	Flare Traversable LT?	N/A	N/A	Flare Traversable RT?	N/A
N/A	Landing Length (in)	N/A	N/A	DWS Provided?	N/A
N/A	Landing Width (in)	N/A	N/A	DWS Contrast?	N/A
N/A	Landing Slope (%)	N/A	N/A	DWS Length (in)	N/A
N/A	Landing X Slope (%)	N/A	N/A	DWS Full Width?	N/A
N/A	Landing Curb? (Y/N)	N/A	N/A	DWS Offset (in)	N/A
N/A	Shared Landing?	N/A			
N/A	Gutter Ponding?	N/A	N/A	Gutter Slope (%)	N/A
N/A	Gutter Lip Ht (in)	N/A	N/A	Gutter X Slope (%)	N/A
N/A	Painted X Walk1?	No	N/A	Painted X Walk2?	No
	X Walk 1 Direction	To N		X Walk 2 Direction	To W
N/A	X Walk 1 Width (in)	N/A	N/A	X Walk 2 Width (in)	N/A
	X Walk 1 Slope (%)	5.0		X Walk 2 Slope (%)	1.4
	X Walk 1 X Slope (%)	0.5		X Walk 2 X Slope (%)	6.5

N/A	Ramp inside XWalk1?	N/A	N/A	Ramp inside XWalk2?	N/A
	Road Slope (%)	4.7	N/A	Clear Space?	N/A
	Road X Slope (%)	6.9	N/A	Clear Space to XWalk (in)	N/A
N/A	Any Obstructions?	N/A	N/A	Storm Grate/Utility Hazard?	N/A
	Obstruction Type			Storm Grate/Utility Type	
		N/A			N/A
			Yes	Surface Condition? (G/P)	Good

**Remove & Replace Curb Ramp With Two New Directional Ramps or Equivalent.**

Total Cost: \$ 3200.00
