# Access Compliance Report

## Public Rights-of-Way

### (Curb Ramps)

| Intersection ID: 30502 | Main Street: ORCHARD_GRASS_CT | Cross Street: STONES_LANDING_ST | Location: NE |

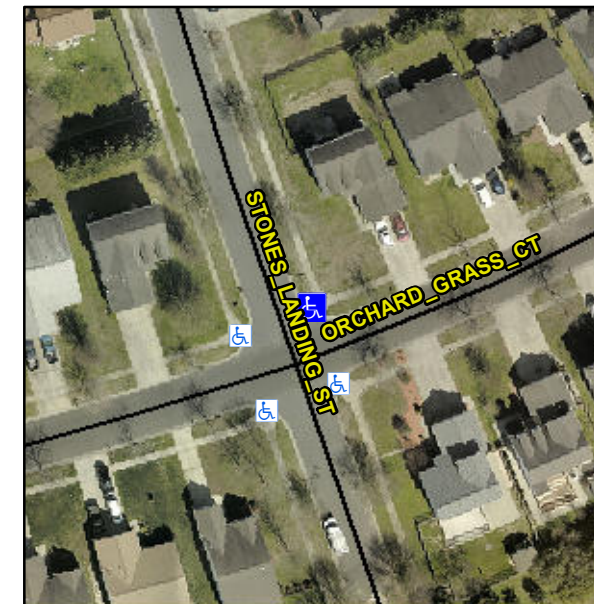
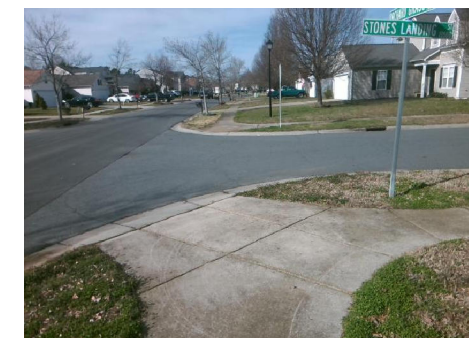
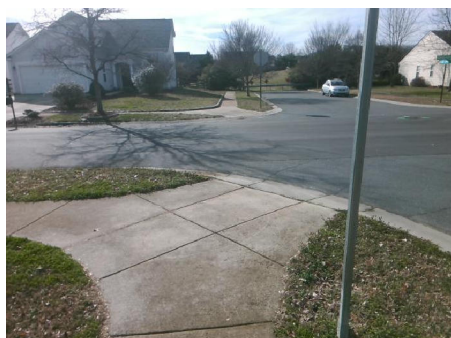
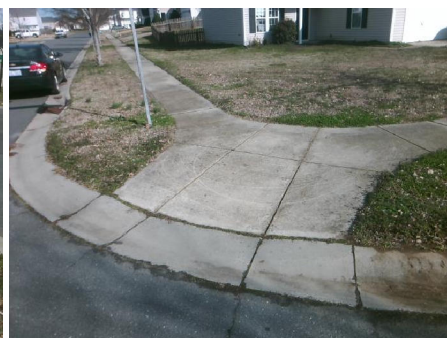
| ADA ID: DB0B8FA90DC9 | Ramp Type: PerpDiag | Initial Pass/Fail: Fail | Overall Compliance: No |

| Compliance | Description | Data | Compliance | Description | Data |
|---|---|---|---|---|---|
| N/A | Ramp Length (in) | 72.0 | Yes | Ramp Slope (%) | 5.2 |
| No | Ramp Width (in) | 40.5 | No | Ramp XSlope (%) | 2.8 |

**Remove & Replace Curb Ramp With Two New Directional Ramps or Equivalent.**

**R304.5.1, R304.5.3**
