Access Compliance Report

Public Rights-of-Way

(Curb Ramps)

Intersection ID: 24178	Main Street: DEHAVILLAND_DR	Cross Street: STRINGFELLOW_LN	Location: SE
ADA ID: DB0DAFCDC04D	Ramp Type: PerpDiag	Initial Pass/Fail: Fail	Overall Compliance: No
Severity Score: 27.5			
Codes/Mitigation Info/Possible Solution		Field Measurements/Component Compliance

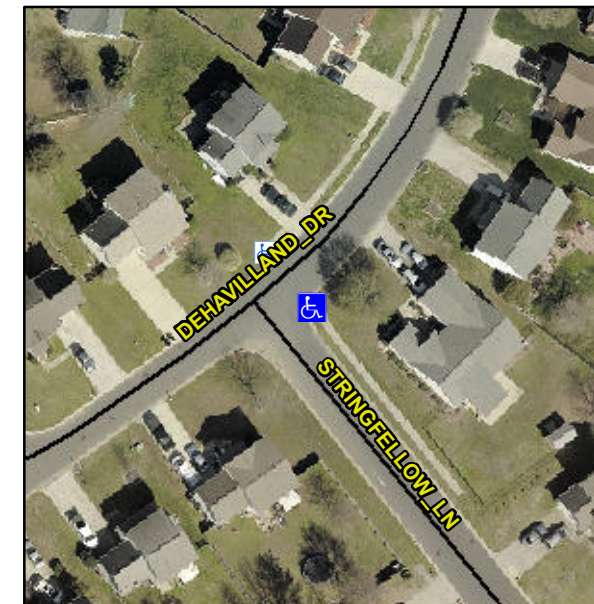
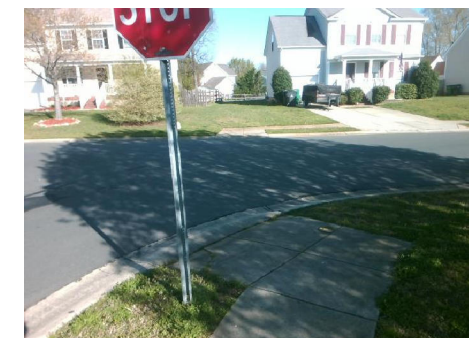
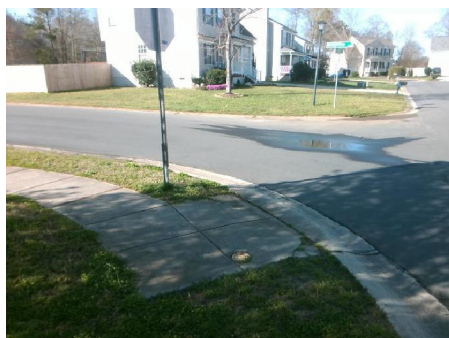
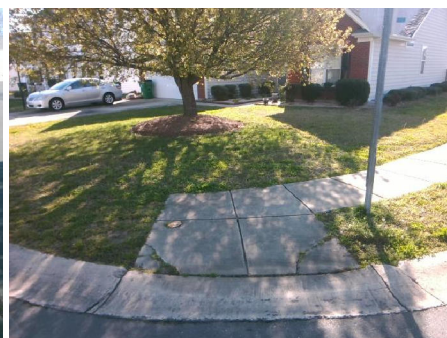
Not Found, R304.2.2, R302.7

Compliance	Description	Data	Compliance	Description	Data
N/A	Ramp Length (in)	45.0	No	Ramp Slope (%)	8.4
Yes	Ramp Width (in)	64.0	Yes	Ramp XSlope (%)	1.4
N/A	Flare Type LT	N/A	N/A	Flare Type RT	N/A
N/A	Flare Slope LT (%)	N/A	N/A	Flare Slope RT (%)	N/A
N/A	Flare Traversable LT?	N/A	N/A	Flare Traversable RT?	N/A
N/A	Landing Length (in)	N/A	N/A	DWS Provided?	N/A
N/A	Landing Width (in)	N/A	N/A	DWS Contrast?	N/A
N/A	Landing Slope (%)	N/A	N/A	DWS Length (in)	N/A
N/A	Landing X Slope (%)	N/A	N/A	DWS Full Width?	N/A
N/A	Landing Curb? (Y/N)	N/A	N/A	DWS Offset (in)	N/A
N/A	Shared Landing?	N/A			
N/A	Gutter Ponding?	N/A	N/A	Gutter Slope (%)	N/A
N/A	Gutter Lip Ht (in)	N/A	N/A	Gutter X Slope (%)	N/A
N/A	Painted X Walk1?	No	N/A	Painted X Walk2?	No
	X Walk 1 Direction	To NW		X Walk 2 Direction	To SW
N/A	X Walk 1 Width (in)	N/A	N/A	X Walk 2 Width (in)	N/A
	X Walk 1 Slope (%)	2.6		X Walk 2 Slope (%)	1.4
	X Walk 1 X Slope (%)	0.2		X Walk 2 X Slope (%)	0.4

N/A	Ramp inside XWalk1?	N/A	N/A	Ramp inside XWalk2?	N/A
	Road Slope (%)	1.6	N/A	Clear Space?	N/A
	Road X Slope (%)	2.0	N/A	Clear Space to XWalk (in)	N/A
N/A	Any Obstructions?	N/A	N/A	Storm Grate/Utility Hazard?	N/A
	Obstruction Type			Storm Grate/Utility Type	
		N/A			N/A
		No		Surface Condition? (G/P)	Poor

Remove & Replace Curb Ramp With Two New Directional Ramps or Equivalent.
