Access Compliance Report

Public Rights-of-Way

(Curb Ramps)

Intersection ID: 31193	Main Street: DICKSON_LN	Cross Street: OLDEN_CT	Location: SE
ADA ID: DB19C6BB7CB6	Ramp Type: Perp	Initial Pass/Fail: Fail	Overall Compliance: No
Severity Score: 33.75			
Codes/Mitigation Info/Possible Solution		Field Measurements/Component Compliance

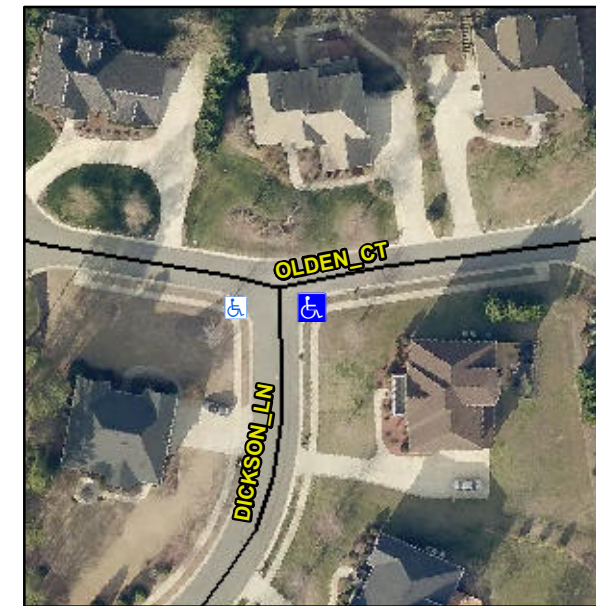
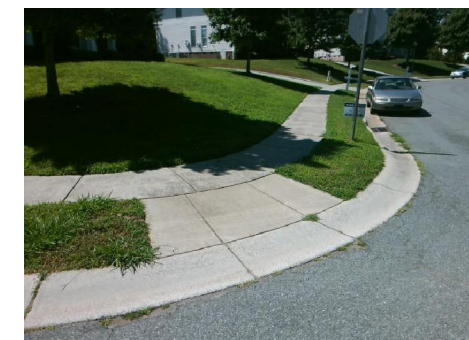
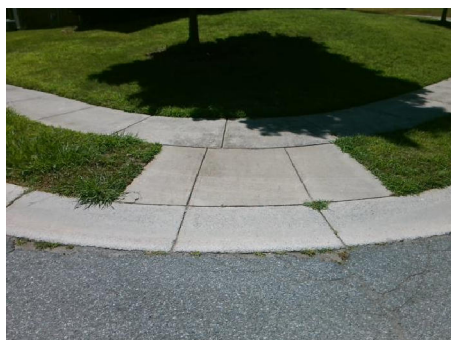
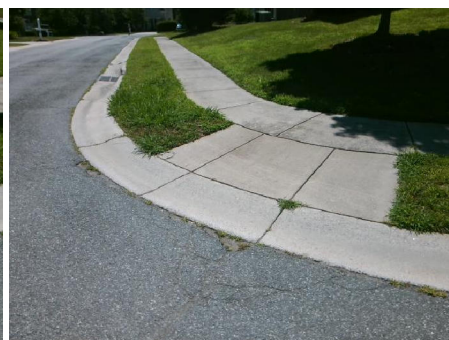
Not Found, R304.5.1, R304.2.2

Compliance	Description	Data	Compliance	Description	Data
N/A	Ramp Length (in)	46.0	No	Ramp Slope (%)	13.0
No	Ramp Width (in)	36.0	Yes	Ramp XSlope (%)	0.2
N/A	Flare Type LT	N/A	N/A	Flare Type RT	N/A
N/A	Flare Slope LT (%)	N/A	N/A	Flare Slope RT (%)	N/A
N/A	Flare Traversable LT?	N/A	N/A	Flare Traversable RT?	N/A
N/A	Landing Length (in)	N/A	N/A	DWS Provided?	N/A
N/A	Landing Width (in)	N/A	N/A	DWS Contrast?	N/A
N/A	Landing Slope (%)	N/A	N/A	DWS Length (in)	N/A
N/A	Landing X Slope (%)	N/A	N/A	DWS Full Width?	N/A
N/A	Landing Curb? (Y/N)	N/A	N/A	DWS Offset (in)	N/A
N/A	Shared Landing?	N/A			
N/A	Gutter Ponding?	N/A	N/A	Gutter Slope (%)	N/A
N/A	Gutter Lip Ht (in)	N/A	N/A	Gutter X Slope (%)	N/A
N/A	Painted X Walk1?	No	N/A	Painted X Walk2?	N/A
	X Walk 1 Direction	To W		X Walk 2 Direction	N/A
N/A	X Walk 1 Width (in)	N/A	N/A	X Walk 2 Width (in)	N/A
	X Walk 1 Slope (%)	1.4		X Walk 2 Slope (%)	N/A
	X Walk 1 X Slope (%)	0.4		X Walk 2 X Slope (%)	N/A

N/A	Ramp inside XWalk1?	N/A	N/A	Ramp inside XWalk2?	N/A
	Road Slope (%)	N/A	N/A	Clear Space?	N/A
	Road X Slope (%)	N/A	N/A	Clear Space to XWalk (in)	N/A
N/A	Any Obstructions?	N/A	N/A	Storm Grate/Utility Hazard?	N/A
	Obstruction Type			Storm Grate/Utility Type	
		N/A			N/A
			Yes	Surface Condition? (G/P)	Good

Remove & Replace Entire Ramp.
