# Access Compliance Report

## Public Rights-of-Way (Curb Ramps)

Intersection ID: 10031811	Main Street: MILLENNIUM_AV	Cross Street: SAGE_PARK_DR	Location:	N
ADA ID: DB2080392622	Ramp Type: Directional1	Initial Pass/Fail: Fail	Overall Compliance: No	Severity Score: 1.25
Codes/Mitigation Info/Possible Solution		Field Measurements/Component Compliance

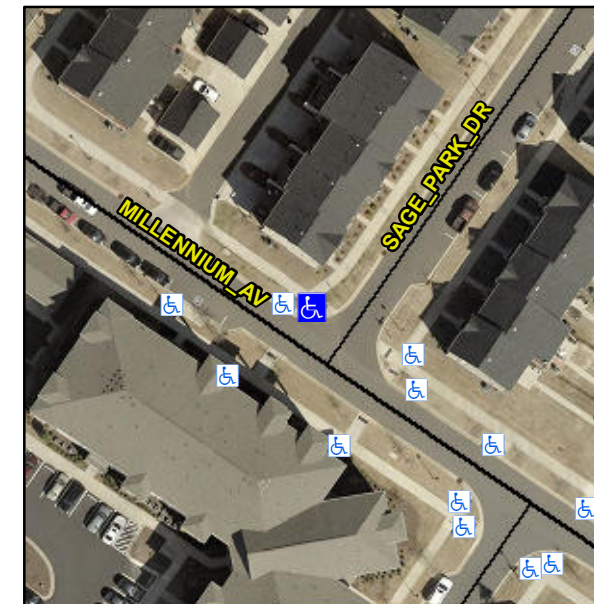
Compliance	Description	Data	Compliance	Description	Data
N/A	Ramp Length (in)	79.0	N/A	Grade Break?	N/A
Yes	Ramp Width (in)	69.0	N/A	Grade Break Slope (%)	0.0
Yes	Ramp Slope (%)	7.8	N/A	Grade Break XSlope (%)	0.0
No	Ramp XSlope (%)	3.1			
N/A	Flare Type LT	N/A	N/A	Flare Type RT	N/A
N/A	Flare Slope LT (%)	N/A	N/A	Flare Slope RT (%)	0.0
N/A	Flare Traversable LT?	N/A	N/A	Flare Traversable RT?	N/A
N/A	Landing Length (in)	0.0	N/A	DWS Provided?	N/A
N/A	Landing Width (in)	0.0	N/A	DWS Contrast?	N/A
N/A	Landing Slope (%)	0.0	N/A	DWS Length (in)	N/A
N/A	Landing X Slope (%)	0.0	N/A	DWS Full Width?	N/A
N/A	Landing Curb? (Y/N)	N/A	N/A	DWS Offset LT (in)	N/A
N/A	Shared Landing?	N/A	N/A	DWS Offset RT (in)	N/A
N/A	Gutter Ponding?	0.0	N/A	Gutter Slope (%)	N/A
N/A	Gutter Lip Ht (in)	0.0	N/A	Gutter X Slope (%)	N/A
N/A	Painted X Walk1?	No		Road Slope (%)	1.6
	X Walk 1 Direction	To SE		Road X Slope (%)	2.4
	X Walk 1 Width (in)	N/A		Clear Space?	N/A

X Walk 1 Slope (%)	1.6	N/A	Clear Space to XWalk (in)	N/A
	X Walk 1 X Slope (%)	2.4	N/A	Storm Grate/Utility Hazard?	N/A
N/A	Ramp inside XWalk1?	N/A		Storm Grate/Utility Type	
N/A	Any Obstructions?	N/A			N/A
	Obstruction Type		Yes	Surface Condition? (G/P)	Good
			N/A	Curb Slope (%)	15.4

Possible Solutions:

**Remove & Replace Entire Ramp.**

**R304.5.3**

\$ 1600.00
