# Access Compliance Report

## Public Rights-of-Way

### (Curb Ramps)

Intersection ID: 48416	Main Street: YORK_CROSSING_DR	Cross Street: S_TRYON_ST	Location: NE
ADA ID: DB210AD7658A	Ramp Type: Perp	Initial Pass/Fail: Fail	Overall Compliance: No
Severity Score: 8.75			
Codes/Mitigation Info/Possible Solution		Field Measurements/Component Compliance

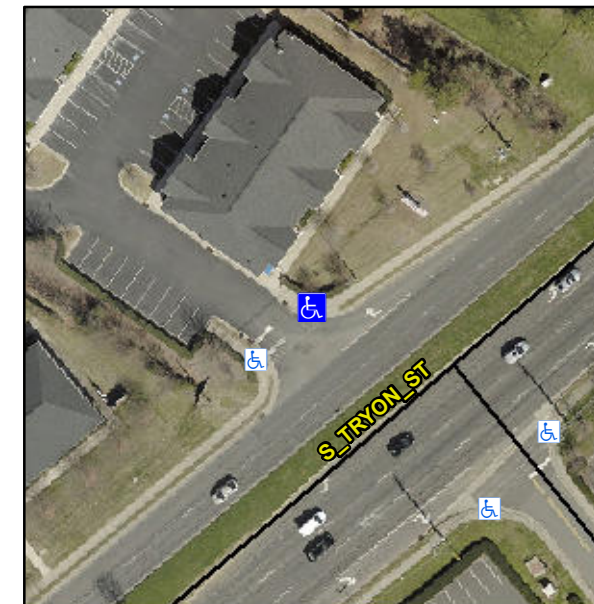
**Not Found, R304.5.1**

Compliance	Description	Data	Compliance	Description	Data
N/A	Ramp Length (in)	89.0	Yes	Ramp Slope (%)	6.6
No	Ramp Width (in)	46.0	Yes	Ramp XSlope (%)	1.8
N/A	Flare Type LT	N/A	N/A	Flare Type RT	N/A
N/A	Flare Slope LT (%)	N/A	N/A	Flare Slope RT (%)	N/A
N/A	Flare Traversable LT?	N/A	N/A	Flare Traversable RT?	N/A
N/A	Landing Length (in)	N/A	N/A	DWS Provided?	N/A
N/A	Landing Width (in)	N/A	N/A	DWS Contrast?	N/A
N/A	Landing Slope (%)	N/A	N/A	DWS Length (in)	N/A
N/A	Landing X Slope (%)	N/A	N/A	DWS Full Width?	N/A
N/A	Landing Curb? (Y/N)	N/A	N/A	DWS Offset (in)	N/A
N/A	Shared Landing?	N/A			
N/A	Gutter Ponding?	N/A	N/A	Gutter Slope (%)	N/A
N/A	Gutter Lip Ht (in)	N/A	N/A	Gutter X Slope (%)	N/A
N/A	Painted X Walk1?	Yes	N/A	Painted X Walk2?	N/A
	X Walk 1 Direction	To W		X Walk 2 Direction	N/A
N/A	X Walk 1 Width (in)	55.0	N/A	X Walk 2 Width (in)	N/A
	X Walk 1 Slope (%)	1.0		X Walk 2 Slope (%)	N/A
	X Walk 1 X Slope (%)	0.2		X Walk 2 X Slope (%)	N/A

N/A	Ramp inside XWalk1?	Yes	N/A	Ramp inside XWalk2?	N/A
	Road Slope (%)	N/A	N/A	Clear Space?	N/A
	Road X Slope (%)	N/A	N/A	Clear Space to XWalk (in)	N/A
N/A	Any Obstructions?	N/A	N/A	Storm Grate/Utility Hazard?	N/A
	Obstruction Type			Storm Grate/Utility Type	
		N/A			N/A
		Yes		Surface Condition? (G/P)	Good

Possible Solutions:

**Remove & Replace Entire Ramp.**

Total Cost: \$ 1850.00
