Access Compliance Report Public Rights-of-Way (Curb Ramps)

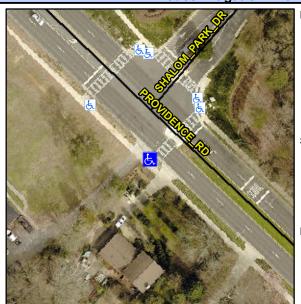
Total Cost: \$ 1850.00

Field Measurements/Component Compliance						
Comp	liance Description	Data	Comp	liance Description	Data	
N/A	Ramp Length (in)	85.0	Yes	Ramp Slope (%)	6.6	
Yes	Ramp Width (in)	71.0	No	Ramp XSlope (%)	5.6	
N/A	Flare Type LT	N/A	N/A	Flare Type RT	N/A	
N/A	Flare Slope LT (%)	N/A	N/A	Flare Slope RT (%)	N/A	
N/A	Flare Traversable LT?	N/A	N/A	Flare Traversable RT?	N/A	
N/A	Landing Length (in)	N/A	N/A	DWS Provided?	N/A	
N/A	Landing Width (in)	N/A	N/A	DWS Contrast?	N/A	
N/A	Landing Slope (%)	N/A	N/A	DWS Length (in)	N/A	
N/A	Landing X Slope (%)	N/A	N/A	DWS Full Width?	N/A	
N/A	Landing Curb? (Y/N)	N/A	N/A	DWS Offset (in)	N/A	
N/A	Shared Landing?	N/A				
N/A	Gutter Ponding?	N/A	N/A	Gutter Slope (%)	N/A	
N/A	Gutter Lip Ht (in)	N/A	N/A	Gutter X Slope (%)	N/A	
N/A	Painted X Walk1?	Yes	N/A	Painted X Walk2?	N/A	
	X Walk 1 Direction	To NE		X Walk 2 Direction	N/A	
N/A	X Walk 1 Width (in)	113.0	N/A	X Walk 2 Width (in)	N/A	
	X Walk 1 Slope (%)	6.4		X Walk 2 Slope (%)	N/A

Street 1 Name PROVIDENCE RD
Stop Condition-Street 2 Signal
Street 2 Name N/A
Stop Condition-Street 1 N/A

Possible Solutions:	Co	
Remove & Replace Entire Ramp.		
-	Ye	
	N/	
Surveyor Notes:	N/	
N/A	N/	
	N/	
	N/	
	N/	
PROW/ADA:	N/	
Not Found, R304.5.3	N/	
	N/	
	N/	
	N/
