Access Compliance Report

Public Rights-of-Way

(Curb Ramps)

Intersection ID: 9968	Main Street: THE_PLAZA	Cross Street: WELDON_AV	Location: SW
ADA ID: DB3537E9CA86	Ramp Type: Directional1	Initial Pass/Fail: Pass	Overall Compliance: No
Codes/Mitigation Info/Possible Solution		Field Measurements/Component Compliance	
Severity Score: 7.5

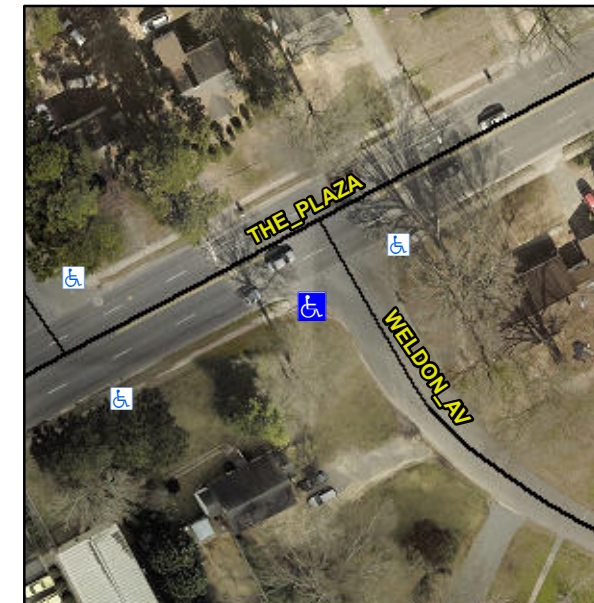
Compliance	Description	Data	Compliance	Description	Data
N/A	Ramp Length (in)	99.5	Yes	Grade Break?	Yes
Yes	Ramp Width (in)	66.5	Yes	Grade Break Slope (%)	0.4
Yes	Ramp Slope (%)	5.7	Yes	Grade Break XSlope (%)	1.8
Yes	Ramp XSlope (%)	1.0			
Yes	Flare Type LT	N/A	Yes	Flare Type RT	N/A
N/A	Flare Slope LT (%)	N/A	N/A	Flare Slope RT (%)	N/A
N/A	Flare Traversable LT?	No	N/A	Flare Traversable RT?	No
Yes	Landing Length (in)	67.0	Yes	DWS Provided?	Yes
Yes	Landing Width (in)	60.0	Yes	DWS Contrast?	Yes
Yes	Landing Slope (%)	0.8	Yes	DWS Length (in)	24.0
Yes	Landing X Slope (%)	1.4	Yes	DWS Full Width?	Yes
N/A	Landing Curb? (Y/N)	N/A	No	DWS Offset LT (in)	74.5
N/A	Shared Landing?	No	Yes	DWS Offset RT (in)	0.0
Yes	Gutter Ponding?	No	Yes	Gutter Slope (%)	2.4
No	Gutter Lip Ht (in)	0.3	Yes	Gutter X Slope (%)	0.3
N/A	Painted X Walk1?	No		Road Slope (%)	0.8
	X Walk 1 Direction	To NE		Road X Slope (%)	1.0
	X Walk 1 Width (in)	N/A		Clear Space?	Yes

X Walk 1 Slope (%)	0.8	N/A	Clear Space to XWalk (in)	N/A
	X Walk 1 X Slope (%)	1.0	Yes	Storm Grate/Utility Hazard?	No
N/A	Ramp inside XWalk1?	N/A		Storm Grate/Utility Type	
Yes	Any Obstructions?	No			N/A
	Obstruction Type		Yes	Surface Condition? (G/P)	Good
			N/A	Curb Slope (%)	4.2

Possible Solutions:

Remove & Replace Detectable Warning System. Grind Gutter Lip.
