Access Compliance Report

Public Rights-of-Way

(Curb Ramps)

Intersection ID: 11902	Main Street: ALLEGHANY_ST	Cross Street: DENVER_AV	Location:	N
ADA ID: DB3922687E74	Ramp Type: Perp	Initial Pass/Fail: Fail	Overall Compliance: No	Severity Score: 8.75

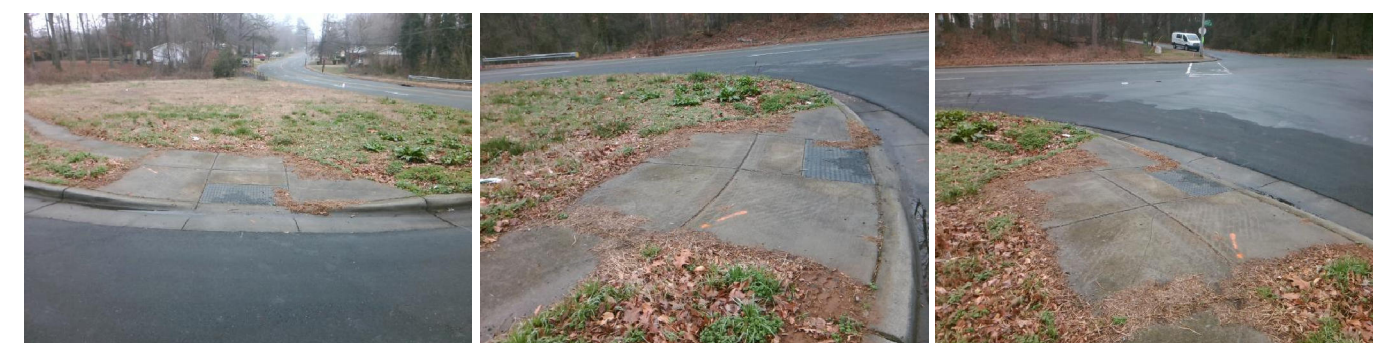
N/A	Shared Landing?	N/A			
	PROW/ADA:		N/A	Gutter Ponding?	N/A	N/A	Gutter Slope (%)	N/A
	Not Found, R304.5.1		N/A	Gutter Lip Ht (in)	N/A	N/A	Gutter X Slope (%)	N/A
			N/A	Painted X Walk1?	No	N/A	Painted X Walk2?	N/A
				X Walk 1 Direction	To SE		X Walk 2 Direction	N/A
			N/A	X Walk 1 Width (in)	N/A	N/A	X Walk 2 Width (in)	N/A
				X Walk 1 Slope (%)	6.8		X Walk 2 Slope (%)	N/A
				X Walk 1 X Slope (%)	8.4		X Walk 2 X Slope (%)	N/A
			N/A	Ramp inside XWalk1?	N/A	N/A	Ramp inside XWalk2?	N/A
			Road Slope (%)	N/A	N/A	Clear Space?	N/A	
			Road X Slope (%)	N/A	N/A	Clear Space to XWalk (in)	N/A	
		N/A	Any Obstructions?	N/A	N/A	Storm Grate/Utility Hazard?	N/A	
			Obstruction Type			Storm Grate/Utility Type		
					N/A		N/A	
						Yes	Surface Condition? (G/P)	Good
Total Cost:		\$ 1850.00

<div>Street 1 Name<div>ALLEGHANY ST</div></div> <div>Stop Condition-Street 2<div>None</div></div> <div>Street 2 Name<div>N/A</div></div> <div>Stop Condition-Street 1<div>N/A</div></div>	Possible Solutions:		Compliance	Description	Data	Compliance	Description	Data
	Remove & Replace Entire Ramp.		N/A	Ramp Length (in)	48.0	Yes	Ramp Slope (%)	7.8
			No	Ramp Width (in)	47.0	Yes	Ramp XSlope (%)	0.8
			N/A	Flare Type LT	N/A	N/A	Flare Type RT	N/A
			N/A	Flare Slope LT (%)	N/A	N/A	Flare Slope RT (%)	N/A
			N/A	Flare Traversable LT?	N/A	N/A	Flare Traversable RT?	N/A
			N/A	Landing Length (in)	N/A	N/A	DWS Provided?	N/A
			N/A	Landing Width (in)	N/A	N/A	DWS Contrast?	N/A
			N/A	Landing Slope (%)	N/A	N/A	DWS Length (in)	N/A
			N/A	Landing X Slope (%)	N/A	N/A	DWS Full Width?	N/A
Surveyor Notes: <div>N/A</div>			N/A	Landing Curb? (Y/N)	N/A	N/A	DWS Offset (in)	N/A
