Access Compliance Report

Public Rights-of-Way

(Curb Ramps)

Intersection ID: 28081	Main Street: PROVIDENCE_GREEN_CT	Cross Street: SHOAL_BROOK_CT	Location: SE
ADA ID: DB427DBCEF82	Ramp Type: Perp	Initial Pass/Fail: Fail	Overall Compliance: No
Severity Score: 8.75			
Codes/Mitigation Info/Possible Solution		Field Measurements/Component Compliance

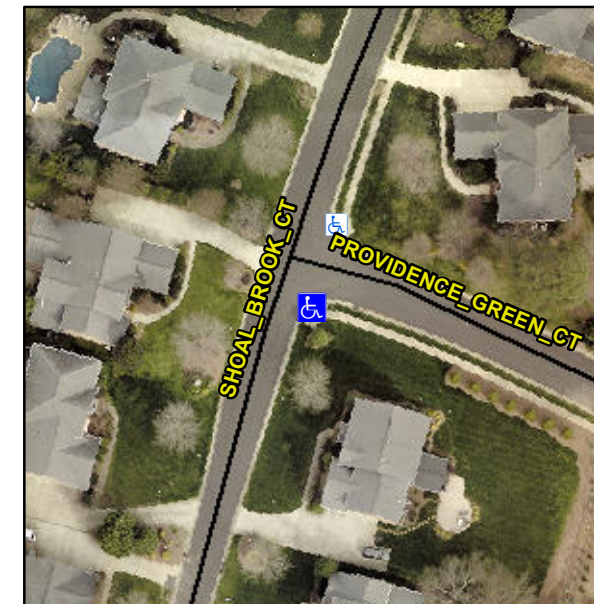
Not Found, R304.5.1

Compliance	Description	Data	Compliance	Description	Data
N/A	Ramp Length (in)	47.0	Yes	Ramp Slope (%)	6.1
No	Ramp Width (in)	43.5	Yes	Ramp XSlope (%)	1.9
N/A	Flare Type LT	N/A	N/A	Flare Type RT	N/A
N/A	Flare Slope LT (%)	N/A	N/A	Flare Slope RT (%)	N/A
N/A	Flare Traversable LT?	N/A	N/A	Flare Traversable RT?	N/A
N/A	Landing Length (in)	N/A	N/A	DWS Provided?	N/A
N/A	Landing Width (in)	N/A	N/A	DWS Contrast?	N/A
N/A	Landing Slope (%)	N/A	N/A	DWS Length (in)	N/A
N/A	Landing X Slope (%)	N/A	N/A	DWS Full Width?	N/A
N/A	Landing Curb? (Y/N)	N/A	N/A	DWS Offset (in)	N/A
N/A	Shared Landing?	N/A			
N/A	Gutter Ponding?	N/A	N/A	Gutter Slope (%)	N/A
N/A	Gutter Lip Ht (in)	N/A	N/A	Gutter X Slope (%)	N/A
N/A	Painted X Walk1?	No	N/A	Painted X Walk2?	N/A
	X Walk 1 Direction	To NE		X Walk 2 Direction	N/A
N/A	X Walk 1 Width (in)	N/A	N/A	X Walk 2 Width (in)	N/A
	X Walk 1 Slope (%)	0.3		X Walk 2 Slope (%)	N/A
	X Walk 1 X Slope (%)	0.9		X Walk 2 X Slope (%)	N/A

Remove & Replace Entire Ramp.
