Access Compliance Report

Public Rights-of-Way

(Curb Ramps)

Intersection ID: 23162	Main Street: SHARON_RD_WEST	Cross Street: SOUTH_BV	Location: NE
ADA ID: DB45F598C9F7	Ramp Type: Perp	Initial Pass/Fail: Fail	Overall Compliance: No
Severity Score: 13.75			
Codes/Mitigation Info/Possible Solution		Field Measurements/Component Compliance

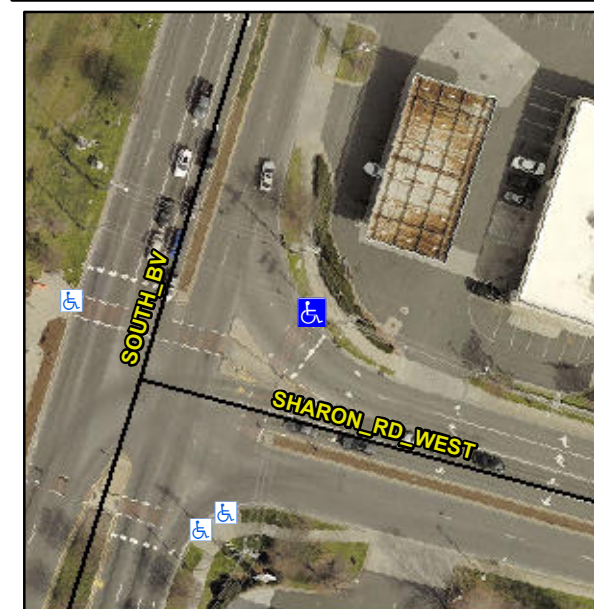
Not Found, R304.2.2, R304.5.3

Compliance	Description	Data	Compliance	Description	Data
N/A	Ramp Length (in)	72.0	No	Ramp Slope (%)	9.7
Yes	Ramp Width (in)	54.0	No	Ramp XSlope (%)	3.9
N/A	Flare Type LT	N/A	N/A	Flare Type RT	N/A
N/A	Flare Slope LT (%)	N/A	N/A	Flare Slope RT (%)	N/A
N/A	Flare Traversable LT?	N/A	N/A	Flare Traversable RT?	N/A
N/A	Landing Length (in)	N/A	N/A	DWS Provided?	N/A
N/A	Landing Width (in)	N/A	N/A	DWS Contrast?	N/A
N/A	Landing Slope (%)	N/A	N/A	DWS Length (in)	N/A
N/A	Landing X Slope (%)	N/A	N/A	DWS Full Width?	N/A
N/A	Landing Curb? (Y/N)	N/A	N/A	DWS Offset (in)	N/A
N/A	Shared Landing?	N/A			
N/A	Gutter Ponding?	N/A	N/A	Gutter Slope (%)	N/A
N/A	Gutter Lip Ht (in)	N/A	N/A	Gutter X Slope (%)	N/A
N/A	Painted X Walk1?	Yes	N/A	Painted X Walk2?	N/A
	X Walk 1 Direction	To SW		X Walk 2 Direction	N/A
N/A	X Walk 1 Width (in)	123.0	N/A	X Walk 2 Width (in)	N/A
	X Walk 1 Slope (%)	2.3		X Walk 2 Slope (%)	N/A
	X Walk 1 X Slope (%)	3.5		X Walk 2 X Slope (%)	N/A

N/A	Ramp inside XWalk1?	Yes	N/A	Ramp inside XWalk2?	N/A
	Road Slope (%)	N/A	N/A	Clear Space?	N/A
	Road X Slope (%)	N/A	N/A	Clear Space to XWalk (in)	N/A
N/A	Any Obstructions?	N/A	N/A	Storm Grate/Utility Hazard?	N/A
	Obstruction Type			Storm Grate/Utility Type	
		N/A			N/A
		Yes		Surface Condition? (G/P)	Good

Possible Solutions:

Remove & Replace Entire Ramp.

Total Cost: \$ 1850.00
