# Access Compliance Report

## Public Rights-of-Way

### (Curb Ramps)

| Intersection ID: 8378 | Main Street: LASALLE_ST | Cross Street: QUENTIN_ST | Location: NW |

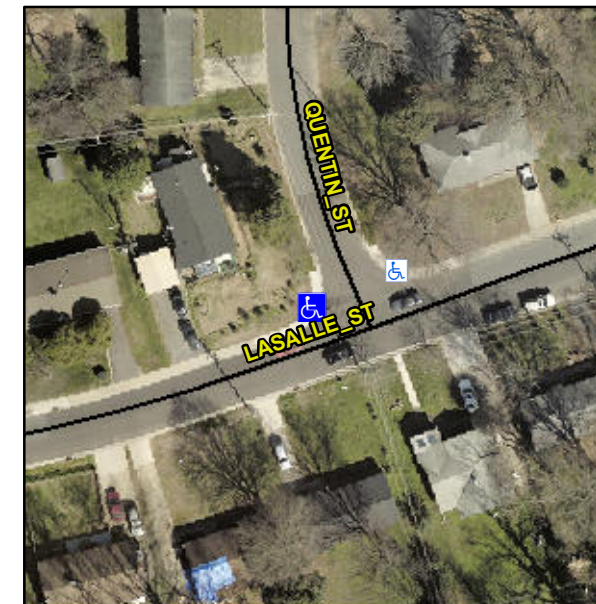
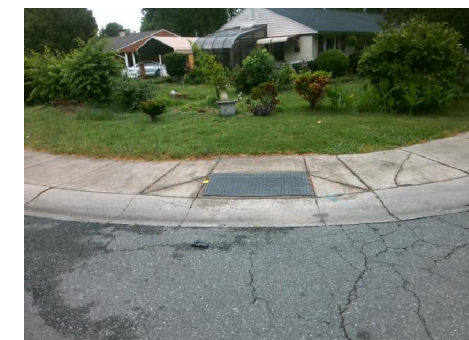
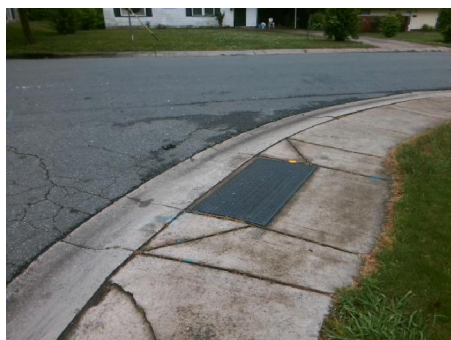
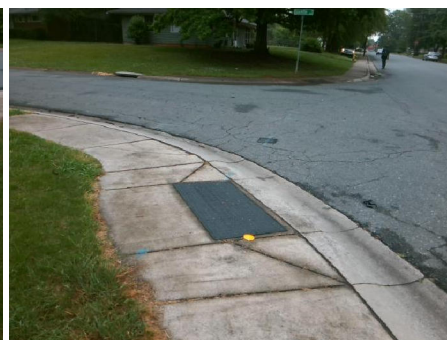
**Not Found, R304.2.1, R304.2.2-Perp,  
R304.3.2-Para, R305.2, R304.5.4,  
R304.5.3**

| Compliance | Description | Data | Compliance | Description | Data |
|---|---|---|---|---|---|
| No | Landing Length (in) | 32.5 | Yes | DWS Provided? | Yes |
| No | Landing Slope (%) | 2.7 | Yes | DWS Length (in) | 25.0 |
| N/A | Landing Curb? (Y/N) | No | No | DWS Offset (in) | 3.0 |
| Yes | Gutter Ponding? | No | No | Gutter Slope (%) | 11.6 |
| Yes | Gutter Lip Ht (in) | 0.0 | No | Gutter X Slope (%) | 2.2 |

**Remove & Replace Entire Ramp.  
Remove & Replace Gutter.**
