# Access Compliance Report

## Public Rights-of-Way (Curb Ramps)

Intersection ID: 50614	Main Street: PADDLE_OAK_RD	Cross Street: BALSAM_BAY_RD	Location: NW
ADA ID: DB54909CD36A	Ramp Type: Perp	Initial Pass/Fail: Fail	Overall Compliance: No
Severity Score: 13.75			
Codes/Mitigation Info/Possible Solution		Field Measurements/Component Compliance

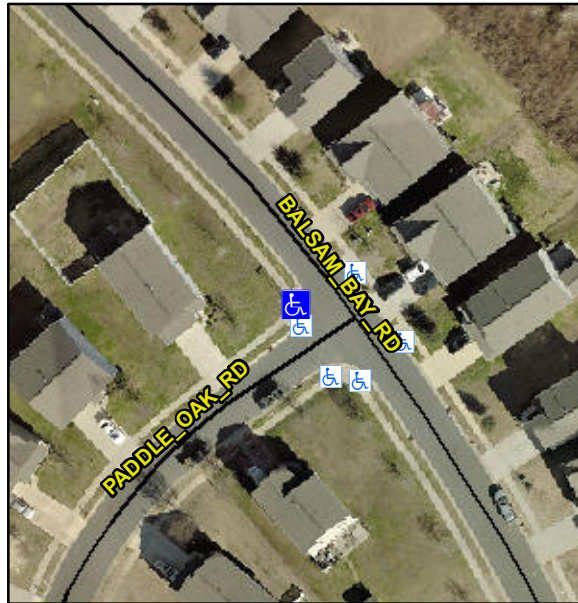
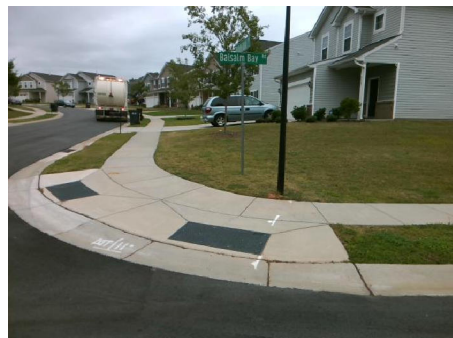
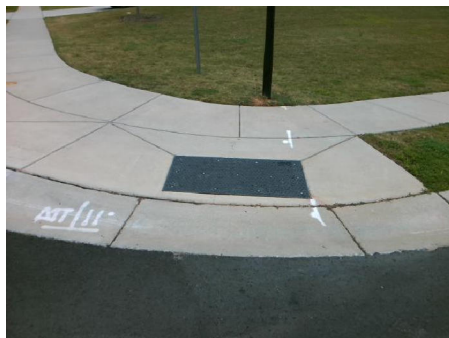
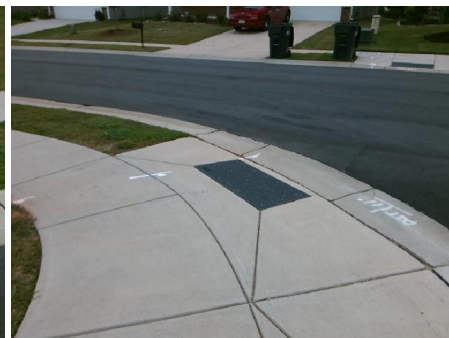
Compliance	Description	Data	Compliance	Description	Data
N/A	Ramp Length (in)	48.0	No	Ramp Slope (%)	9.2
Yes	Ramp Width (in)	48.0	No	Ramp XSlope (%)	4.6
N/A	Flare Type LT	N/A	N/A	Flare Type RT	N/A
N/A	Flare Slope LT (%)	N/A	N/A	Flare Slope RT (%)	N/A
N/A	Flare Traversable LT?	N/A	N/A	Flare Traversable RT?	N/A
N/A	Landing Length (in)	N/A	N/A	DWS Provided?	N/A
N/A	Landing Width (in)	N/A	N/A	DWS Contrast?	N/A
N/A	Landing Slope (%)	N/A	N/A	DWS Length (in)	N/A
N/A	Landing X Slope (%)	N/A	N/A	DWS Full Width?	N/A
N/A	Landing Curb? (Y/N)	N/A	N/A	DWS Offset (in)	N/A
N/A	Shared Landing?	N/A			
N/A	Gutter Ponding?	N/A	N/A	Gutter Slope (%)	N/A
N/A	Gutter Lip Ht (in)	N/A	N/A	Gutter X Slope (%)	N/A
N/A	Painted X Walk1?	No	N/A	Painted X Walk2?	N/A
	X Walk 1 Direction	To E		X Walk 2 Direction	N/A
N/A	X Walk 1 Width (in)	N/A	N/A	X Walk 2 Width (in)	N/A
	X Walk 1 Slope (%)	2.4		X Walk 2 Slope (%)	N/A
	X Walk 1 X Slope (%)	4.1		X Walk 2 X Slope (%)	N/A

N/A	Ramp inside XWalk1?	N/A	N/A	Ramp inside XWalk2?	N/A
	Road Slope (%)	N/A	N/A	Clear Space?	N/A
	Road X Slope (%)	N/A	N/A	Clear Space to XWalk (in)	N/A
N/A	Any Obstructions?	N/A	N/A	Storm Grate/Utility Hazard?	N/A
	Obstruction Type			Storm Grate/Utility Type	
		N/A			N/A
			Yes	Surface Condition? (G/P)	Good

**Remove & Replace Entire Ramp.**
