# Access Compliance Report

## Public Rights-of-Way

### (Curb Ramps)

Intersection ID: N/A	Main Street: SOUTHGROVE_ST	Cross Street: WAVERLY_WALK_AV	Location: NW
ADA ID: DB5A09CFCA0A	Ramp Type: Perp	Initial Pass/Fail: Fail	Overall Compliance: No
		Severity Score: 22.5

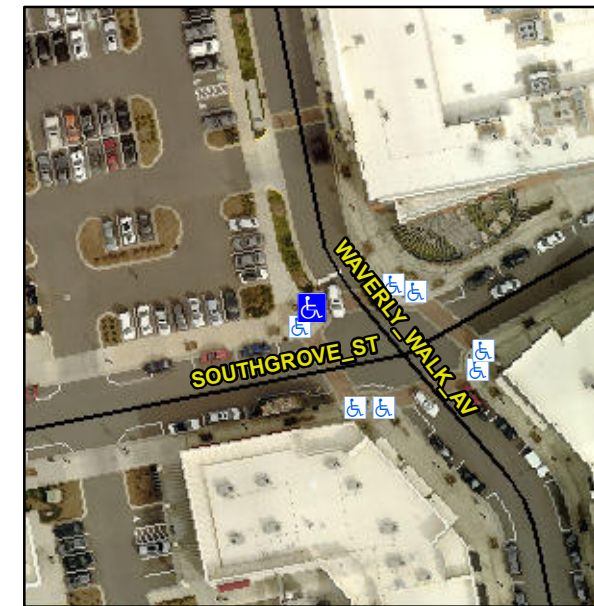
**R304.5.1, R304.2.2, R304.5.3**

Compliance	Description	Data	Compliance	Description	Data
N/A	Ramp Length (in)	98.0	No	Ramp Slope (%)	9.0
No	Ramp Width (in)	46.5	No	Ramp XSlope (%)	3.4
N/A	Flare Type LT	N/A	N/A	Flare Type RT	N/A
N/A	Flare Slope LT (%)	N/A	N/A	Flare Slope RT (%)	N/A
N/A	Flare Traversable LT?	N/A	N/A	Flare Traversable RT?	N/A
N/A	Landing Length (in)	N/A	N/A	DWS Provided?	N/A
N/A	Landing Width (in)	N/A	N/A	DWS Contrast?	N/A
N/A	Landing Slope (%)	N/A	N/A	DWS Length (in)	N/A
N/A	Landing X Slope (%)	N/A	N/A	DWS Full Width?	N/A
N/A	Landing Curb? (Y/N)	N/A	N/A	DWS Offset (in)	N/A
N/A	Shared Landing?	N/A			
N/A	Gutter Ponding?	N/A	N/A	Gutter Slope (%)	N/A
N/A	Gutter Lip Ht (in)	N/A	N/A	Gutter X Slope (%)	N/A
N/A	Painted X Walk1?	Yes	N/A	Painted X Walk2?	N/A
	X Walk 1 Direction	To E		X Walk 2 Direction	N/A
N/A	X Walk 1 Width (in)	104.0	N/A	X Walk 2 Width (in)	N/A
	X Walk 1 Slope (%)	0.6		X Walk 2 Slope (%)	N/A
	X Walk 1 X Slope (%)	0.0		X Walk 2 X Slope (%)	N/A

N/A	Ramp inside XWalk1?	Yes	N/A	Ramp inside XWalk2?	N/A
	Road Slope (%)	N/A	N/A	Clear Space?	N/A
	Road X Slope (%)	N/A	N/A	Clear Space to XWalk (in)	N/A
N/A	Any Obstructions?	N/A	N/A	Storm Grate/Utility Hazard?	N/A
	Obstruction Type			Storm Grate/Utility Type	
		N/A			N/A
			Yes	Surface Condition? (G/P)	Good

**Remove & Replace Entire Ramp.**

Total Cost: \$ 1850.00
