Access Compliance Report

Public Rights-of-Way

(Curb Ramps)

Intersection ID: 48492	Main Street: SHOPTON_RD_WEST	Cross Street: BEREWICK_COMMONS_PY	Location: NW
ADA ID: DB5AB044A8D2	Ramp Type: Perp	Initial Pass/Fail: Fail	Overall Compliance: No
Severity Score: 25			
Codes/Mitigation Info/Possible Solution		Field Measurements/Component Compliance

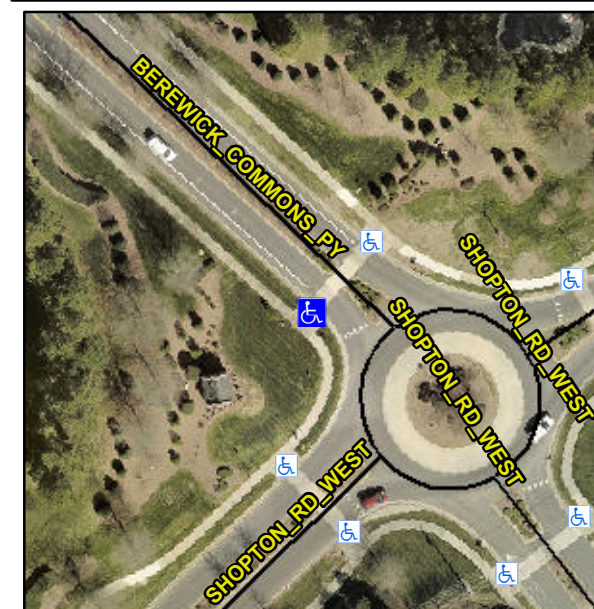
Compliance	Description	Data	Compliance	Description	Data
N/A	Ramp Length (in)	94.0	Yes	Ramp Slope (%)	6.9
Yes	Ramp Width (in)	48.0	No	Ramp XSlope (%)	8.0
N/A	Flare Type LT	N/A	N/A	Flare Type RT	N/A
N/A	Flare Slope LT (%)	N/A	N/A	Flare Slope RT (%)	N/A
N/A	Flare Traversable LT?	N/A	N/A	Flare Traversable RT?	N/A
N/A	Landing Length (in)	N/A	N/A	DWS Provided?	N/A
N/A	Landing Width (in)	N/A	N/A	DWS Contrast?	N/A
N/A	Landing Slope (%)	N/A	N/A	DWS Length (in)	N/A
N/A	Landing X Slope (%)	N/A	N/A	DWS Full Width?	N/A
N/A	Landing Curb? (Y/N)	N/A	N/A	DWS Offset (in)	N/A
N/A	Shared Landing?	N/A			
N/A	Gutter Ponding?	N/A	N/A	Gutter Slope (%)	N/A
N/A	Gutter Lip Ht (in)	N/A	N/A	Gutter X Slope (%)	N/A
N/A	Painted X Walk1?	Yes	N/A	Painted X Walk2?	N/A
	X Walk 1 Direction	To NE		X Walk 2 Direction	N/A
N/A	X Walk 1 Width (in)	98.0	N/A	X Walk 2 Width (in)	N/A
	X Walk 1 Slope (%)	4.8		X Walk 2 Slope (%)	N/A
	X Walk 1 X Slope (%)	2.2		X Walk 2 X Slope (%)	N/A

N/A	Ramp inside XWalk1?	Yes	N/A	Ramp inside XWalk2?	N/A
	Road Slope (%)	N/A	N/A	Clear Space?	N/A
	Road X Slope (%)	N/A	N/A	Clear Space to XWalk (in)	N/A
N/A	Any Obstructions?	N/A	N/A	Storm Grate/Utility Hazard?	N/A
	Obstruction Type			Storm Grate/Utility Type	
		N/A			N/A
		Yes		Surface Condition? (G/P)	Good

Possible Solutions:

Remove & Replace Entire Ramp.
