Access Compliance Report

Public Rights-of-Way

(Curb Ramps)

Intersection ID: 15173	Main Street: ALBEMARLE_RD	Cross Street: EXECUTIVE_CENTER_DR	Location: NW
ADA ID: DB5C3A37FA73	Ramp Type: Para	Initial Pass/Fail: Fail	Overall Compliance: No
			Severity Score: 13.75

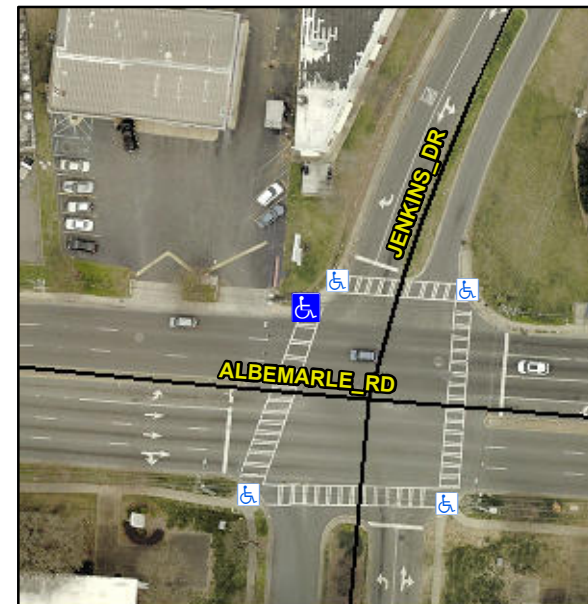
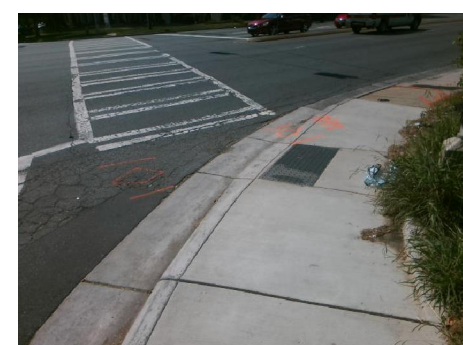
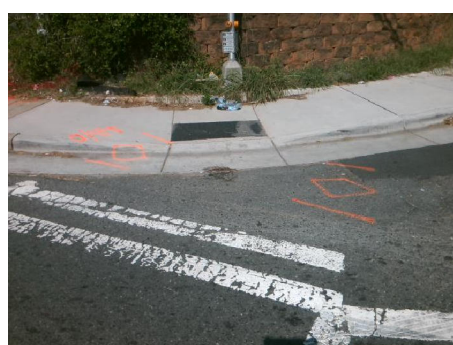
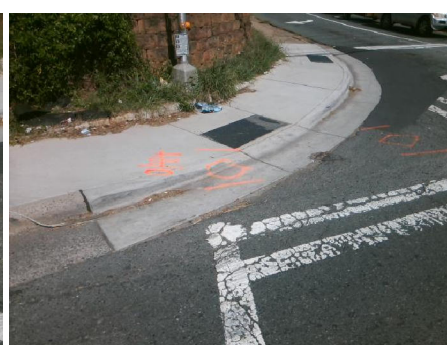
R304.3.2, R304.5.3

Compliance	Description	Data	Compliance	Description	Data
N/A	Ramp Length LT (in)	76.0	N/A	Ramp Length RT (in)	64.0
Yes	Ramp Width LT (in)	60.0	Yes	Ramp Width RT (in)	57.0
No	Ramp Slope LT (%)	8.6	Yes	Ramp Slope RT (%)	7.0
Yes	Ramp XSlope LT (%)	0.5	No	Ramp XSlope RT (%)	2.6
N/A	Landing Length (in)	N/A	N/A	DWS Provided?	N/A
N/A	Landing Width (in)	N/A	N/A	DWS Contrast?	N/A
N/A	Landing Slope (%)	N/A	N/A	DWS Length (in)	N/A
N/A	Landing X Slope (%)	N/A	N/A	DWS Full Width?	N/A
N/A	Landing Curb? (Y/N)	N/A	N/A	DWS Offset (in)	N/A
N/A	Shared Landing?	N/A			
N/A	Gutter Ponding?	N/A	N/A	Gutter Slope (%)	N/A
N/A	Gutter Lip Ht (in)	N/A	N/A	Gutter X Slope (%)	N/A
N/A	Painted X Walk1?	Yes	N/A	Painted X Walk2?	N/A
	X Walk 1 Direction	To S		X Walk 2 Direction	N/A
N/A	X Walk 1 Width (in)	117.0	N/A	X Walk 2 Width (in)	N/A
	X Walk 1 Slope (%)	4.9		X Walk 2 Slope (%)	N/A
	X Walk 1 X Slope (%)	0.2		X Walk 2 X Slope (%)	N/A
N/A	Ramp inside XWalk1?	Yes	N/A	Ramp inside XWalk2?	N/A

Road Slope (%)	N/A	N/A	Clear Space?	N/A
	Road X Slope (%)	N/A	N/A	Clear Space to XWalk (in)	N/A
N/A	Any Obstructions?	N/A	N/A	Storm Grate/Utility Hazard?	N/A
	Obstruction Type			Storm Grate/Utility Type	
		N/A			N/A
			Yes	Surface Condition? (G/P)	Good
			N/A	Curb Slope (%)	10.4

Remove & Replace Entire Ramp.

Total Cost: \$ 1600.00
