Access Compliance Report

Public Rights-of-Way

(Curb Ramps)

Intersection ID: 11611	Main Street: VICTORIA_AV	Cross Street: W_4TH_ST_EXT	Location: SE
ADA ID: DB675B80EEBF	Ramp Type: Perp	Initial Pass/Fail: Fail	Overall Compliance: No
Severity Score: 12.5			
Codes/Mitigation Info/Possible Solution		Field Measurements/Component Compliance

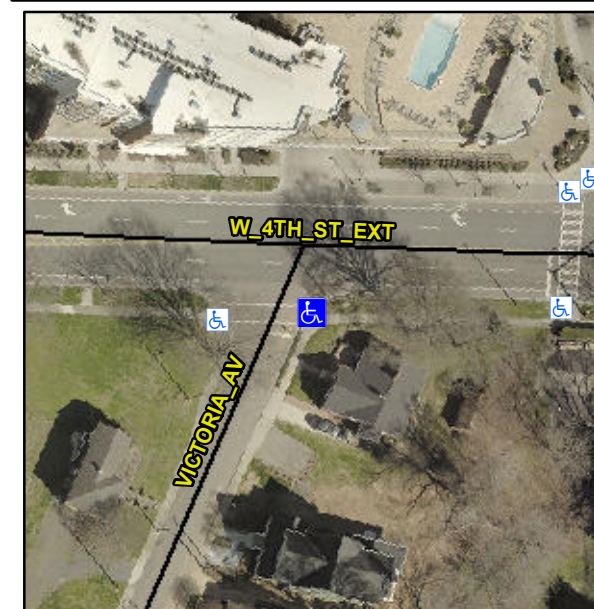
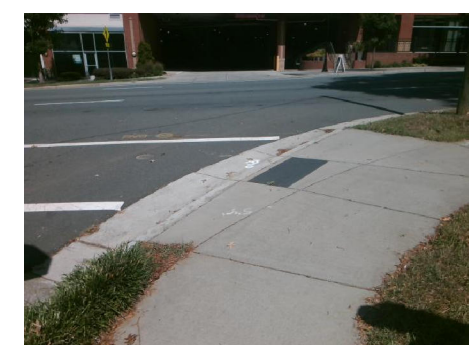
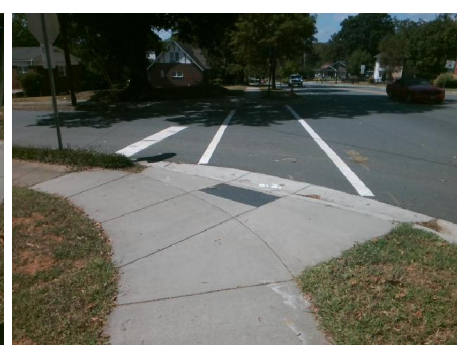
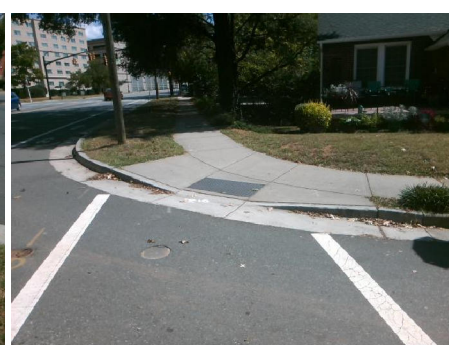
Not Found, R304.5.3

Compliance	Description	Data	Compliance	Description	Data
N/A	Ramp Length (in)	35.0	Yes	Ramp Slope (%)	6.2
Yes	Ramp Width (in)	48.0	No	Ramp XSlope (%)	5.3
N/A	Flare Type LT	N/A	N/A	Flare Type RT	N/A
N/A	Flare Slope LT (%)	N/A	N/A	Flare Slope RT (%)	N/A
N/A	Flare Traversable LT?	N/A	N/A	Flare Traversable RT?	N/A
N/A	Landing Length (in)	N/A	N/A	DWS Provided?	N/A
N/A	Landing Width (in)	N/A	N/A	DWS Contrast?	N/A
N/A	Landing Slope (%)	N/A	N/A	DWS Length (in)	N/A
N/A	Landing X Slope (%)	N/A	N/A	DWS Full Width?	N/A
N/A	Landing Curb? (Y/N)	N/A	N/A	DWS Offset (in)	N/A
N/A	Shared Landing?	N/A			
N/A	Gutter Ponding?	N/A	N/A	Gutter Slope (%)	N/A
N/A	Gutter Lip Ht (in)	N/A	N/A	Gutter X Slope (%)	N/A
N/A	Painted X Walk1?	Yes	N/A	Painted X Walk2?	N/A
	X Walk 1 Direction	To W		X Walk 2 Direction	N/A
N/A	X Walk 1 Width (in)	104.0	N/A	X Walk 2 Width (in)	N/A
	X Walk 1 Slope (%)	0.8		X Walk 2 Slope (%)	N/A
	X Walk 1 X Slope (%)	8.6		X Walk 2 X Slope (%)	N/A

N/A	Ramp inside XWalk1?	Yes	N/A	Ramp inside XWalk2?	N/A
	Road Slope (%)	N/A	N/A	Clear Space?	N/A
	Road X Slope (%)	N/A	N/A	Clear Space to XWalk (in)	N/A
N/A	Any Obstructions?	N/A	N/A	Storm Grate/Utility Hazard?	N/A
	Obstruction Type			Storm Grate/Utility Type	
		N/A			N/A
		Yes		Surface Condition? (G/P)	Good

Possible Solutions:

Remove & Replace Entire Ramp.
