Access Compliance Report Public Rights-of-Way (Curb Ramps)

Intersection ID: 45283 Main Street: ARWEN RD Cross Street: CIERA_NICHOLE_CT Location: Ε

ADA ID: DB6C501C4996 Ramp Type: PerpDiag Initial Pass/Fail: Fail **Overall Compliance: No Severity Score:** 8.75

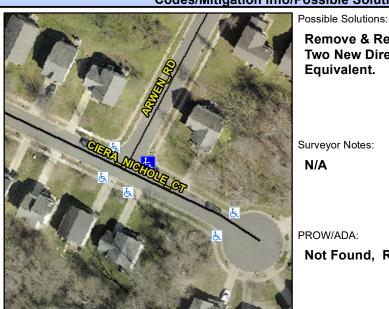
Not Found, R304.5.1

r leid measurements/component compnance					
Compliance Description		Data	Compliance Description		Data
N/A	Ramp Length (in)	48.0	Yes	Ramp Slope (%)	7.5
No	Ramp Width (in)	39.0	Yes	Ramp XSlope (%)	1.1
N/A	Flare Type LT	N/A	N/A	Flare Type RT	N/A
N/A	Flare Slope LT (%)	N/A	N/A	Flare Slope RT (%)	N/A
N/A	Flare Traversable LT?	N/A	N/A	Flare Traversable RT?	N/A
N/A	Landing Length (in)	N/A	N/A	DWS Provided?	N/A
N/A	Landing Width (in)	N/A	N/A	DWS Contrast?	N/A
N/A	Landing Slope (%)	N/A	N/A	DWS Length (in)	N/A
N/A	Landing X Slope (%)	N/A	N/A	DWS Full Width?	N/A
N/A	Landing Curb? (Y/N)	N/A	N/A	DWS Offset (in)	N/A
N/A	Shared Landing?	N/A			
N/A	Gutter Ponding?	N/A	N/A	Gutter Slope (%)	N/A
N/A	Gutter Lip Ht (in)	N/A	N/A	Gutter X Slope (%)	N/A
N/A	Painted X Walk1?	No	N/A	Painted X Walk2?	No
	X Walk 1 Direction	To NW		X Walk 2 Direction	To SW
N/A	X Walk 1 Width (in)	N/A	N/A	X Walk 2 Width (in)	N/A
	X Walk 1 Slope (%)	4.5		X Walk 2 Slope (%)	1.2

X Walk 1 X Slope (%)	0.6		X Walk 2 X Slope (%)	2.6
N/A	Ramp inside XWalk1?	N/A	N/A	Ramp inside XWalk2?	N/A
	Road Slope (%)	2.1	N/A	Clear Space?	N/A
	Road X Slope (%)	2.2	N/A	Clear Space to XWalk (in)	N/A
N/A	Any Obstructions?	N/A	N/A	Storm Grate/Utility Hazard?	N/A
	Obstruction Type			Storm Grate/Utility Type	
		N/A			N/A

Remove & Replace Curb Ramp With Two New Directional Ramps or Equivalent.
