Access Compliance Report

Public Rights-of-Way

(Curb Ramps)

Intersection ID: 43155	Main Street: E_W_T_HARRIS_BV	Cross Street: LINDA_LAKE_DR	Location: NE
ADA ID: DB702EE56BAD	Ramp Type: PerpDiag	Initial Pass/Fail: Fail	Overall Compliance: No
Severity Score: 13.75			
Codes/Mitigation Info/Possible Solution		Field Measurements/Component Compliance

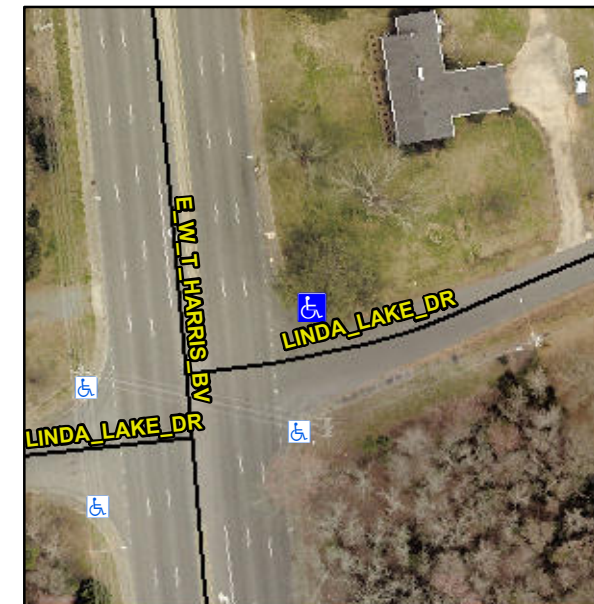
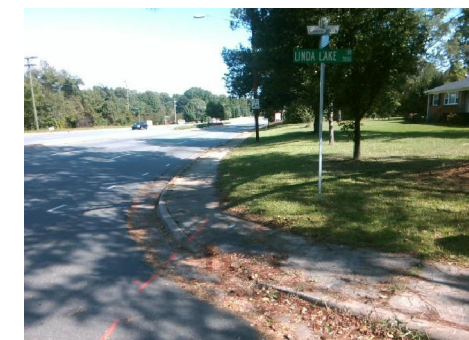
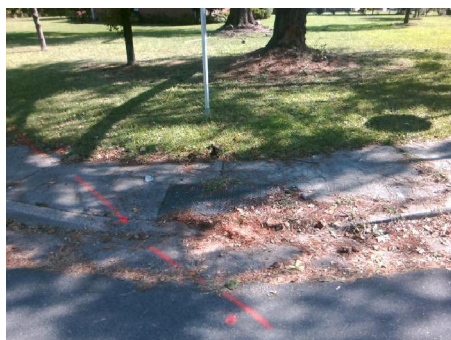
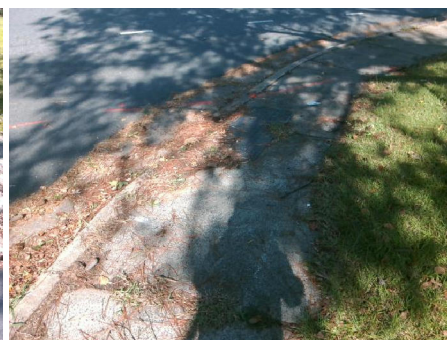
Not Found, R304.2.2, R304.5.3

Compliance	Description	Data	Compliance	Description	Data
N/A	Ramp Length (in)	60.0	No	Ramp Slope (%)	8.7
Yes	Ramp Width (in)	48.0	No	Ramp XSlope (%)	4.1
N/A	Flare Type LT	N/A	N/A	Flare Type RT	N/A
N/A	Flare Slope LT (%)	N/A	N/A	Flare Slope RT (%)	N/A
N/A	Flare Traversable LT?	N/A	N/A	Flare Traversable RT?	N/A
N/A	Landing Length (in)	N/A	N/A	DWS Provided?	N/A
N/A	Landing Width (in)	N/A	N/A	DWS Contrast?	N/A
N/A	Landing Slope (%)	N/A	N/A	DWS Length (in)	N/A
N/A	Landing X Slope (%)	N/A	N/A	DWS Full Width?	N/A
N/A	Landing Curb? (Y/N)	N/A	N/A	DWS Offset (in)	N/A
N/A	Shared Landing?	N/A			
N/A	Gutter Ponding?	Yes	N/A	Gutter Slope (%)	N/A
N/A	Gutter Lip Ht (in)	N/A	N/A	Gutter X Slope (%)	N/A
N/A	Painted X Walk1?	No	N/A	Painted X Walk2?	No
	X Walk 1 Direction	To W		X Walk 2 Direction	To S
N/A	X Walk 1 Width (in)	N/A	N/A	X Walk 2 Width (in)	N/A
	X Walk 1 Slope (%)	0.8		X Walk 2 Slope (%)	1.0
	X Walk 1 X Slope (%)	1.4		X Walk 2 X Slope (%)	2.7

N/A	Ramp inside XWalk1?	N/A	N/A	Ramp inside XWalk2?	N/A
	Road Slope (%)	2.7	N/A	Clear Space?	N/A
	Road X Slope (%)	1.8	N/A	Clear Space to XWalk (in)	N/A
N/A	Any Obstructions?	N/A	N/A	Storm Grate/Utility Hazard?	N/A
	Obstruction Type			Storm Grate/Utility Type	
		N/A			N/A
		Yes		Surface Condition? (G/P)	Good

Remove & Replace Curb Ramp With Two New Directional Ramps or Equivalent.
