Access Compliance Report

Public Rights-of-Way

(Curb Ramps)

Intersection ID: 11318	Main Street: GRANDIN_RD	Cross Street: W_4TH_ST_EXT	Location: N
ADA ID: DB75F207F623	Ramp Type: Para	Initial Pass/Fail: Fail	Overall Compliance: No
Severity Score: 12.5			
Codes/Mitigation Info/Possible Solution		Field Measurements/Component Compliance

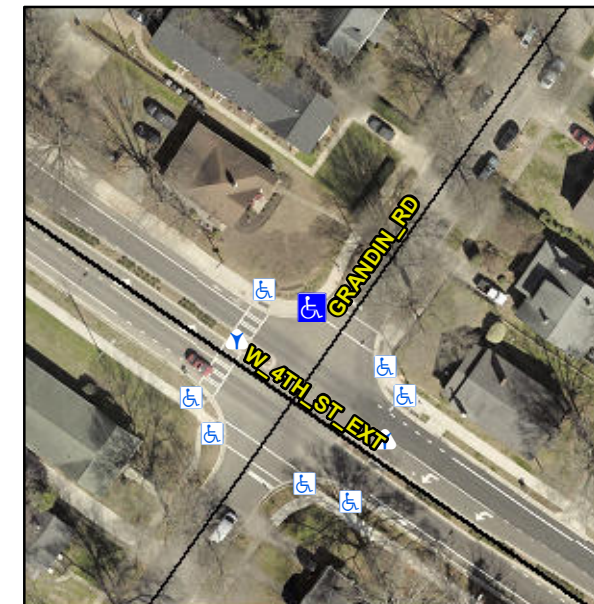
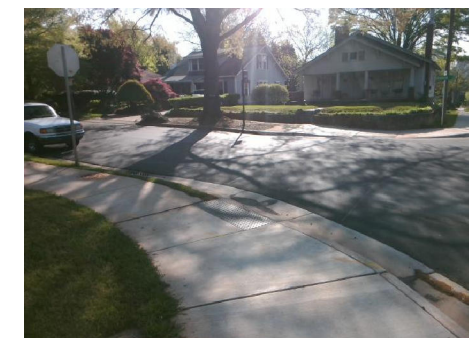
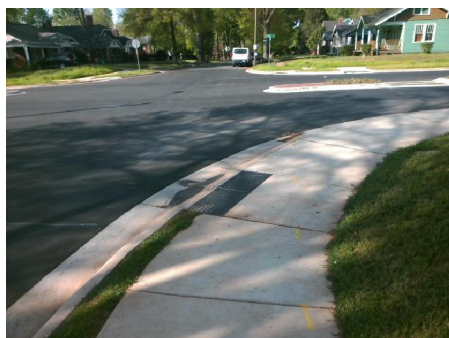
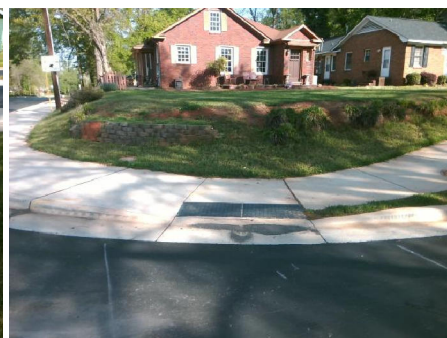
Compliance	Description	Data	Compliance	Description	Data
N/A	Ramp Length LT (in)	64.0	N/A	Ramp Length RT (in)	59.0
Yes	Ramp Width LT (in)	84.0	Yes	Ramp Width RT (in)	75.0
Yes	Ramp Slope LT (%)	6.1	No	Ramp Slope RT (%)	8.6
Yes	Ramp XSlope LT (%)	1.0	Yes	Ramp XSlope RT (%)	1.5
N/A	Landing Length (in)	N/A	N/A	DWS Provided?	N/A
N/A	Landing Width (in)	N/A	N/A	DWS Contrast?	N/A
N/A	Landing Slope (%)	N/A	N/A	DWS Length (in)	N/A
N/A	Landing X Slope (%)	N/A	N/A	DWS Full Width?	N/A
N/A	Landing Curb? (Y/N)	N/A	N/A	DWS Offset (in)	N/A
N/A	Shared Landing?	N/A			
N/A	Gutter Ponding?	N/A	N/A	Gutter Slope (%)	N/A
N/A	Gutter Lip Ht (in)	N/A	N/A	Gutter X Slope (%)	N/A
N/A	Painted X Walk1?	No	N/A	Painted X Walk2?	N/A
	X Walk 1 Direction	To SE		X Walk 2 Direction	N/A
N/A	X Walk 1 Width (in)	N/A	N/A	X Walk 2 Width (in)	N/A
	X Walk 1 Slope (%)	0.1		X Walk 2 Slope (%)	N/A
	X Walk 1 X Slope (%)	0.1		X Walk 2 X Slope (%)	N/A
N/A	Ramp inside XWalk1?	N/A	N/A	Ramp inside XWalk2?	N/A

Road Slope (%)	N/A	N/A	Clear Space?	N/A
	Road X Slope (%)	N/A	N/A	Clear Space to XWalk (in)	N/A
N/A	Any Obstructions?	N/A	N/A	Storm Grate/Utility Hazard?	N/A
	Obstruction Type			Storm Grate/Utility Type	
		N/A			N/A
			Yes	Surface Condition? (G/P)	Good
			N/A	Curb Slope (%)	8.8

Remove & Replace Entire Ramp.

R304.3.2

\$ 1600.00
