Access Compliance Report

Public Rights-of-Way

(Curb Ramps)

Intersection ID: 10180	Main Street: FERN_AV	Cross Street: TUCKASEEGEE_RD	Location: NE
ADA ID: DB78A3797A41	Ramp Type: Perp	Initial Pass/Fail: Fail	Overall Compliance: No
		Severity Score: 25

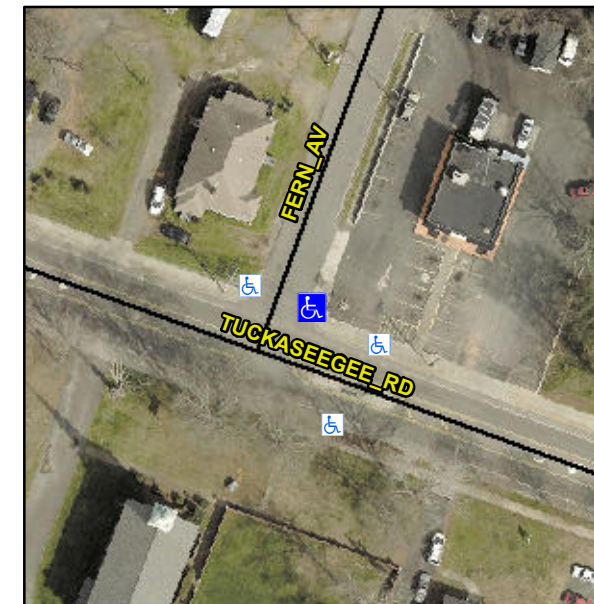
Not Found, R304.2.2, R304.5.3

Compliance	Description	Data	Compliance	Description	Data
N/A	Ramp Length (in)	78.5	No	Ramp Slope (%)	10.4
Yes	Ramp Width (in)	48.0	No	Ramp XSlope (%)	6.7
N/A	Flare Type LT	N/A	N/A	Flare Type RT	N/A
N/A	Flare Slope LT (%)	N/A	N/A	Flare Slope RT (%)	N/A
N/A	Flare Traversable LT?	N/A	N/A	Flare Traversable RT?	N/A
N/A	Landing Length (in)	N/A	N/A	DWS Provided?	N/A
N/A	Landing Width (in)	N/A	N/A	DWS Contrast?	N/A
N/A	Landing Slope (%)	N/A	N/A	DWS Length (in)	N/A
N/A	Landing X Slope (%)	N/A	N/A	DWS Full Width?	N/A
N/A	Landing Curb? (Y/N)	N/A	N/A	DWS Offset (in)	N/A
N/A	Shared Landing?	N/A			
N/A	Gutter Ponding?	N/A	N/A	Gutter Slope (%)	N/A
N/A	Gutter Lip Ht (in)	N/A	N/A	Gutter X Slope (%)	N/A
N/A	Painted X Walk1?	No	N/A	Painted X Walk2?	N/A
	X Walk 1 Direction	To W		X Walk 2 Direction	N/A
N/A	X Walk 1 Width (in)	N/A	N/A	X Walk 2 Width (in)	N/A
	X Walk 1 Slope (%)	8.0		X Walk 2 Slope (%)	N/A
	X Walk 1 X Slope (%)	7.3		X Walk 2 X Slope (%)	N/A

Remove & Replace Entire Ramp.
