Access Compliance Report

Public Rights-of-Way

(Curb Ramps)

Intersection ID: N/A	Main Street: WILORA_LAKE_RD	Cross Street: N/A	Location: NE
ADA ID: DB7E2E777350	Ramp Type: PerpDiag	Initial Pass/Fail: Fail	Overall Compliance: No
Codes/Mitigation Info/Possible Solution		Field Measurements/Component Compliance	
		Severity Score: 25

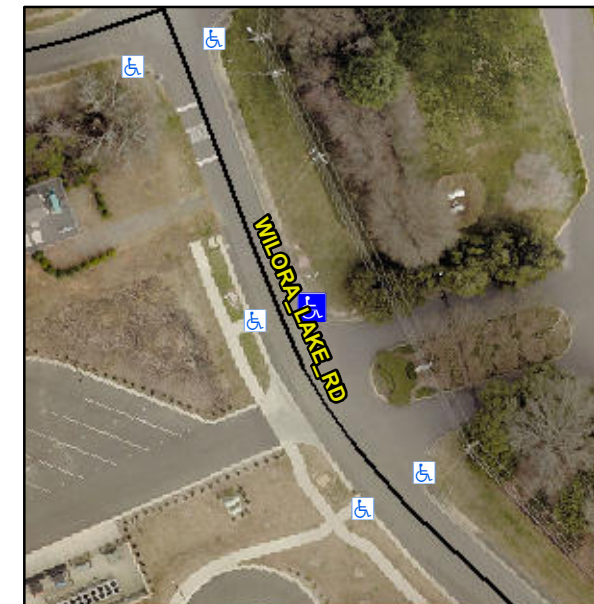
Not Found, R304.2.2, R304.5.3

Compliance	Description	Data	Compliance	Description	Data
N/A	Ramp Length (in)	49.0	No	Ramp Slope (%)	11.0
Yes	Ramp Width (in)	53.0	No	Ramp XSlope (%)	5.4
N/A	Flare Type LT	N/A	N/A	Flare Type RT	N/A
N/A	Flare Slope LT (%)	N/A	N/A	Flare Slope RT (%)	N/A
N/A	Flare Traversable LT?	N/A	N/A	Flare Traversable RT?	N/A
N/A	Landing Length (in)	N/A	N/A	DWS Provided?	N/A
N/A	Landing Width (in)	N/A	N/A	DWS Contrast?	N/A
N/A	Landing Slope (%)	N/A	N/A	DWS Length (in)	N/A
N/A	Landing X Slope (%)	N/A	N/A	DWS Full Width?	N/A
N/A	Landing Curb? (Y/N)	N/A	N/A	DWS Offset (in)	N/A
N/A	Shared Landing?	N/A			
N/A	Gutter Ponding?	N/A	N/A	Gutter Slope (%)	N/A
N/A	Gutter Lip Ht (in)	N/A	N/A	Gutter X Slope (%)	N/A
N/A	Painted X Walk1?	No	N/A	Painted X Walk2?	No
	X Walk 1 Direction	To W		X Walk 2 Direction	To S
N/A	X Walk 1 Width (in)	N/A	N/A	X Walk 2 Width (in)	N/A
	X Walk 1 Slope (%)	6.6		X Walk 2 Slope (%)	0.4
	X Walk 1 X Slope (%)	0.1		X Walk 2 X Slope (%)	8.5

N/A	Ramp inside XWalk1?	N/A	N/A	Ramp inside XWalk2?	N/A
	Road Slope (%)	7.6	N/A	Clear Space?	N/A
	Road X Slope (%)	13.2	N/A	Clear Space to XWalk (in)	N/A
N/A	Any Obstructions?	N/A	N/A	Storm Grate/Utility Hazard?	N/A
	Obstruction Type			Storm Grate/Utility Type	
		N/A			N/A
			Yes	Surface Condition? (G/P)	Good

Possible Solutions:

Remove & Replace Curb Ramp With Two New Directional Ramps or Equivalent.
