# Access Compliance Report

## Public Rights-of-Way

### (Curb Ramps)

| Intersection ID: 10023717 | Main Street: COLEY_VIEW_CT | Cross Street: N/A | Location: NE |

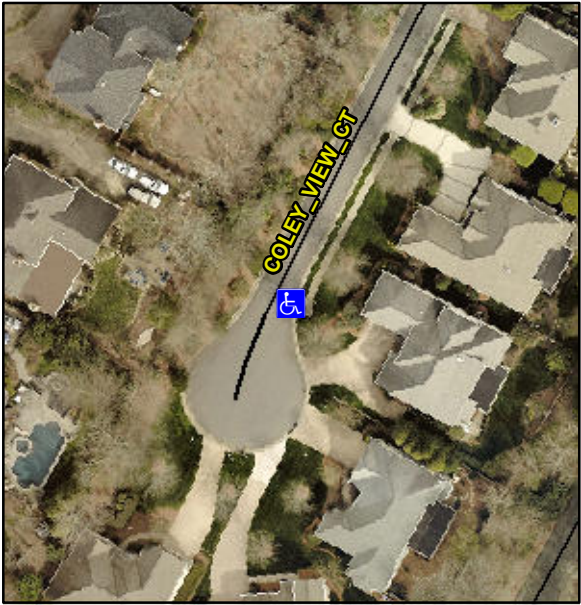
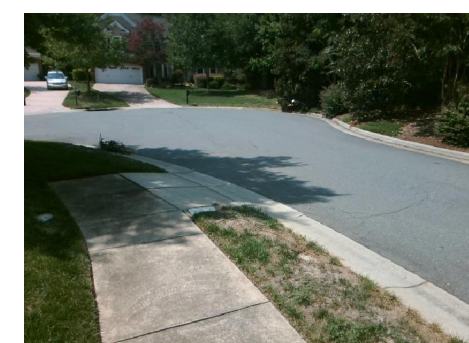
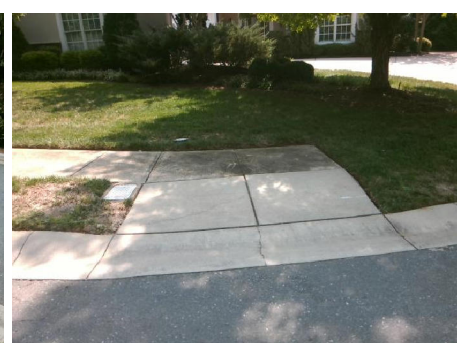
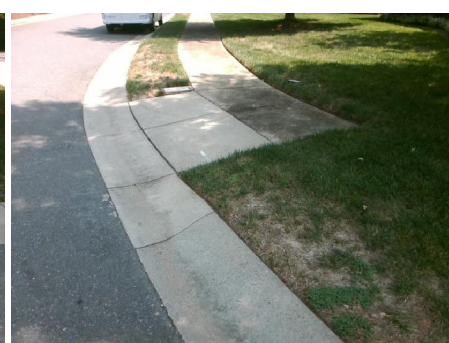
| ADA ID: DB9E9A96AED5 | Ramp Type: Perp | Initial Pass/Fail: Fail | Overall Compliance: No |

| | Remove & Replace Entire Ramp. | N/A | Ramp Length (in) | 42.0 | No | Ramp Slope (%) | 14.8 |
| <p>Surveyor Notes:</p> <p>N/A</p> <p>PROW/ADA:</p> <p>Not Found, R304.2.2</p> | | | X Walk 1 Direction | To W | | X Walk 2 Direction | N/A |
