# Access Compliance Report

## Public Rights-of-Way

### (Curb Ramps)

| Intersection ID: 27531 | Main Street: BALLANTYNE COMMONS PY | Cross Street: PLANTATION PARK BV | Location: | N |

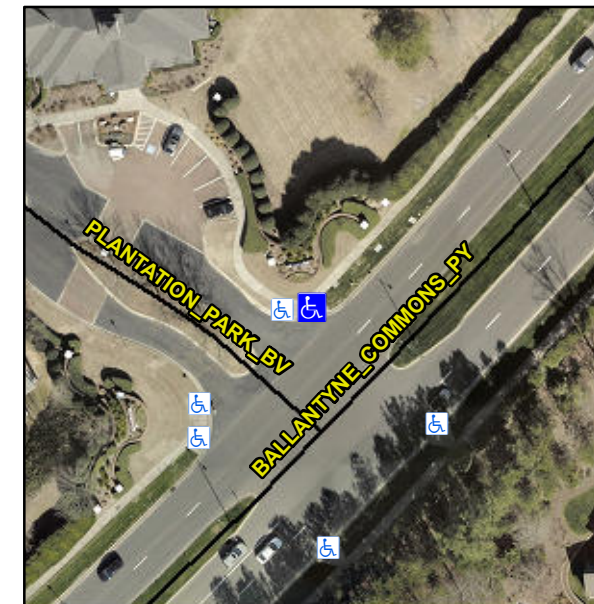
**Not Found, R304.5.1, R304.5.3**

| Compliance | Description | Data | Compliance | Description | Data |
|---|---|---|---|---|---|
| No | Ramp Width (in) | 45.0 | No | BlendTrans XSlope (%) | 7.1 |

**Remove & Replace Curb Ramp With Two New Directional Ramps or Equivalent.**

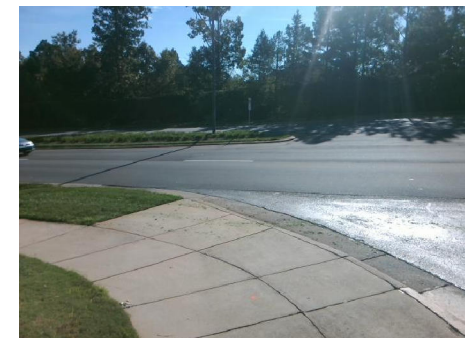
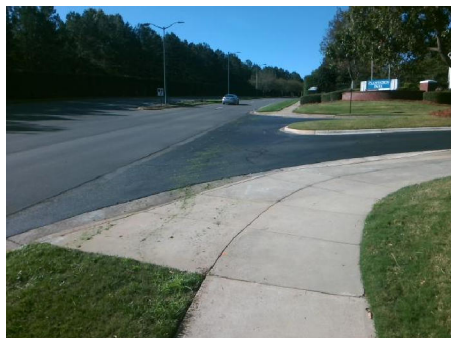
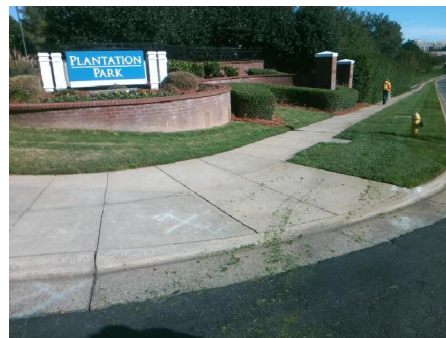
| Compliance | Description | Data | Compliance | Description | Data |
|---|---|---|---|---|---|
| | | | No | Curb Slope (%) | 25.7 |
