Access Compliance Report Public Rights-of-Way (Curb Ramps)

Intersection ID: 45490 Main Street: COTTON_STAND_RD Cross Street: GRASSY_CROPS_RD Location: SE

ADA ID: DBA8A0034F22 Ramp Type: PerpDiag Initial Pass/Fail: Fail Overall Compliance: No Severity Score: 21.25

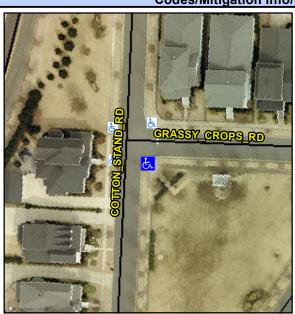
PROW/ADA:
Not Found, R304.5.1, R304.2.2

Compliance Description Data Compliance Description Data No N/A Ramp Length (in) 72.0 Ramp Slope (%) 10.8 Yes No Ramp Width (in) 37.0 Ramp XSlope (%) 1.0 N/A N/A Flare Type LT N/A Flare Type RT N/A N/A N/A N/A Flare Slope RT (%) Flare Slope LT (%) N/A N/A Flare Traversable LT? N/A N/A Flare Traversable RT? N/A N/A N/A N/A **DWS Provided?** N/A Landing Length (in) N/A Landing Width (in) N/A N/A **DWS Contrast?** N/A N/A N/A N/A Landing Slope (%) DWS Length (in) N/A N/A Landing X Slope (%) N/A N/A DWS Full Width? N/A N/A Landing Curb? (Y/N) N/A N/A DWS Offset (in) N/A N/A N/A Shared Landing? N/A **Gutter Ponding?** N/A N/A Gutter Slope (%) N/A N/A Gutter Lip Ht (in) N/A N/A Gutter X Slope (%) N/A N/A Painted X Walk1? No N/A Painted X Walk2? No X Walk 1 Direction To N X Walk 2 Direction To W N/A N/A X Walk 1 Width (in) X Walk 2 Width (in) N/A X Walk 1 Slope (%) 2.9 X Walk 2 Slope (%) 3.7 X Walk 1 X Slope (%) 4.7 X Walk 2 X Slope (%) 2.7 N/A N/A N/A Ramp inside XWalk2? N/A Ramp inside XWalk1? Road Slope (%) 1.3 N/A Clear Space? N/A N/A Road X Slope (%) Clear Space to XWalk (in) N/A 4.2 N/A N/A N/A Any Obstructions? Storm Grate/Utility Hazard? N/A **Obstruction Type** Storm Grate/Utility Type N/A N/A Yes Surface Condition? (G/P) Good

Remove & Replace Curb Ramp With
Two New Directional Ramps or
Equivalent.
