# Access Compliance Report

## Public Rights-of-Way

| Intersection ID: 20109 | Main Street: COLUMBINE_CR | Cross Street: COLUMBINE_CT | Location: SW |
| ADA ID: DBAEE2CC6636 | Ramp Type: PerpDiag | Initial Pass/Fail: Fail | Overall Compliance: No |

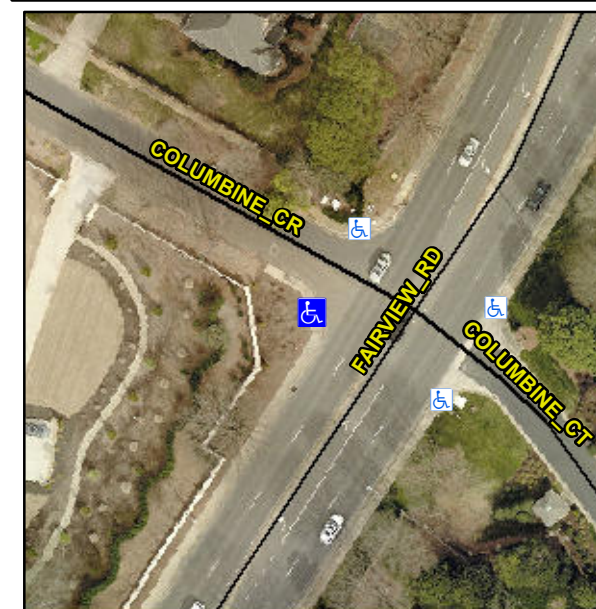
**Not Found, R304.2.2**

| Compliance | Description | Data | Compliance | Description | Data |
|---|---|---|---|---|---|
| N/A | Ramp Length (in) | 59.0 | No | Ramp Slope (%) | 8.5 |
| Yes | Ramp Width (in) | 48.0 | Yes | Ramp XSlope (%) | 1.2 |
| | | | Yes | Surface Condition? (G/P) | Good |

**Remove & Replace Curb Ramp With Two New Directional Ramps or Equivalent.**

Total Cost: \$ 3200.00
