# Access Compliance Report

## Public Rights-of-Way

### (Curb Ramps)

Intersection ID: 3845	Main Street: ZIEGLER_LN	Cross Street: DERVISH_LN	Location:	S
ADA ID: DBB4E336B345	Ramp Type: PerpDiag	Initial Pass/Fail: Fail	Overall Compliance: No	Severity Score: 10
Codes/Mitigation Info/Possible Solution		Field Measurements/Component Compliance

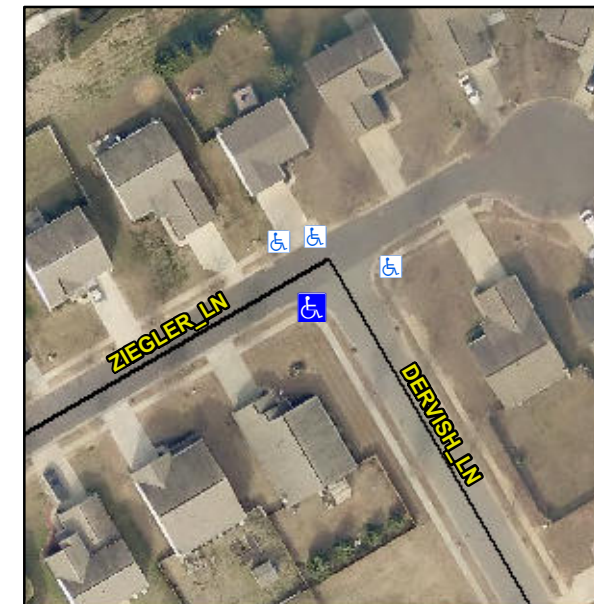
**Not Found, R304.5.1, R304.5.3**

Compliance	Description	Data	Compliance	Description	Data
N/A	Ramp Length (in)	50.0	Yes	Ramp Slope (%)	6.4
No	Ramp Width (in)	37.0	No	Ramp XSlope (%)	2.4
N/A	Flare Type LT	N/A	N/A	Flare Type RT	N/A
N/A	Flare Slope LT (%)	N/A	N/A	Flare Slope RT (%)	N/A
N/A	Flare Traversable LT?	N/A	N/A	Flare Traversable RT?	N/A
N/A	Landing Length (in)	N/A	N/A	DWS Provided?	N/A
N/A	Landing Width (in)	N/A	N/A	DWS Contrast?	N/A
N/A	Landing Slope (%)	N/A	N/A	DWS Length (in)	N/A
N/A	Landing X Slope (%)	N/A	N/A	DWS Full Width?	N/A
N/A	Landing Curb? (Y/N)	N/A	N/A	DWS Offset (in)	N/A
N/A	Shared Landing?	N/A			
N/A	Gutter Ponding?	N/A	N/A	Gutter Slope (%)	N/A
N/A	Gutter Lip Ht (in)	N/A	N/A	Gutter X Slope (%)	N/A
N/A	Painted X Walk1?	No	N/A	Painted X Walk2?	No
	X Walk 1 Direction	To E		X Walk 2 Direction	To N
N/A	X Walk 1 Width (in)	N/A	N/A	X Walk 2 Width (in)	N/A
	X Walk 1 Slope (%)	1.9		X Walk 2 Slope (%)	5.7
	X Walk 1 X Slope (%)	2.3		X Walk 2 X Slope (%)	0.3

N/A	Ramp inside XWalk1?	N/A	N/A	Ramp inside XWalk2?	N/A
	Road Slope (%)	3.0	N/A	Clear Space?	N/A
	Road X Slope (%)	4.7	N/A	Clear Space to XWalk (in)	N/A
N/A	Any Obstructions?	N/A	N/A	Storm Grate/Utility Hazard?	N/A
	Obstruction Type			Storm Grate/Utility Type	
		N/A			N/A
			Yes	Surface Condition? (G/P)	Good

**Remove & Replace Curb Ramp With Two New Directional Ramps or Equivalent.**

Total Cost: \$ 3200.00
