Access Compliance Report

Public Rights-of-Way

(Curb Ramps)

Intersection ID: 3107	Main Street: GROSBEAK_LN	Cross Street: MOURNING_DOVE_LN	Location: E
ADA ID: DBCAAA289268	Ramp Type: Perp	Initial Pass/Fail: Fail	Overall Compliance: No
Severity Score: 35			
Codes/Mitigation Info/Possible Solution		Field Measurements/Component Compliance

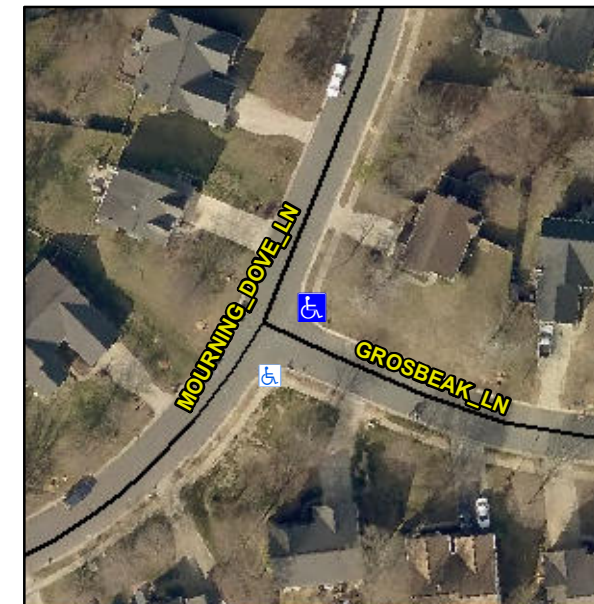
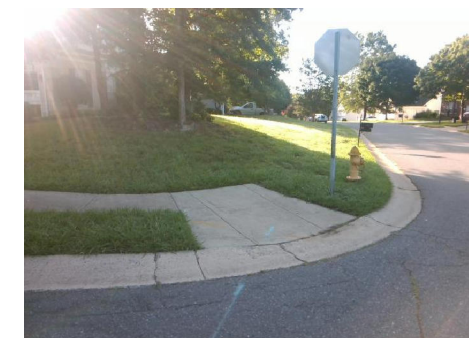
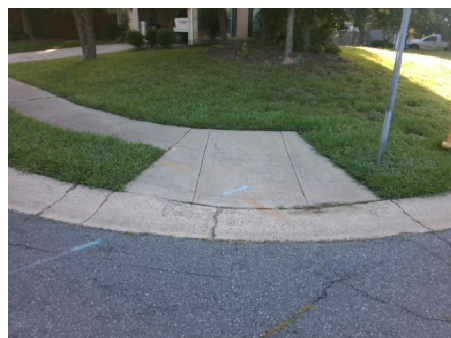
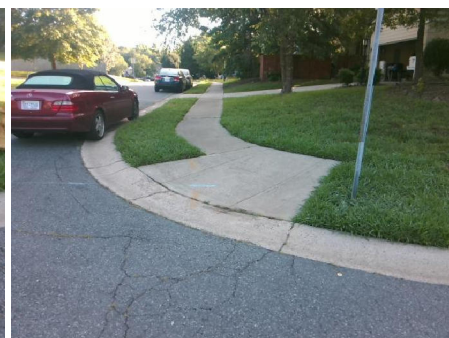
R304.5.1, R304.2.2, R304.5.3

Compliance	Description	Data	Compliance	Description	Data
N/A	Ramp Length (in)	98.0	No	Ramp Slope (%)	13.1
No	Ramp Width (in)	46.5	No	Ramp XSlope (%)	4.3
N/A	Flare Type LT	N/A	N/A	Flare Type RT	N/A
N/A	Flare Slope LT (%)	N/A	N/A	Flare Slope RT (%)	N/A
N/A	Flare Traversable LT?	N/A	N/A	Flare Traversable RT?	N/A
N/A	Landing Length (in)	N/A	N/A	DWS Provided?	N/A
N/A	Landing Width (in)	N/A	N/A	DWS Contrast?	N/A
N/A	Landing Slope (%)	N/A	N/A	DWS Length (in)	N/A
N/A	Landing X Slope (%)	N/A	N/A	DWS Full Width?	N/A
N/A	Landing Curb? (Y/N)	N/A	N/A	DWS Offset (in)	N/A
N/A	Shared Landing?	N/A			
N/A	Gutter Ponding?	N/A	N/A	Gutter Slope (%)	N/A
N/A	Gutter Lip Ht (in)	N/A	N/A	Gutter X Slope (%)	N/A
N/A	Painted X Walk1?	No	N/A	Painted X Walk2?	N/A
	X Walk 1 Direction	To SW		X Walk 2 Direction	N/A
N/A	X Walk 1 Width (in)	N/A	N/A	X Walk 2 Width (in)	N/A
	X Walk 1 Slope (%)	1.0		X Walk 2 Slope (%)	N/A
	X Walk 1 X Slope (%)	1.8		X Walk 2 X Slope (%)	N/A

N/A	Ramp inside XWalk1?	N/A	N/A	Ramp inside XWalk2?	N/A
	Road Slope (%)	N/A	N/A	Clear Space?	N/A
	Road X Slope (%)	N/A	N/A	Clear Space to XWalk (in)	N/A
N/A	Any Obstructions?	N/A	N/A	Storm Grate/Utility Hazard?	N/A
	Obstruction Type			Storm Grate/Utility Type	
		N/A			N/A
			Yes	Surface Condition? (G/P)	Good

Possible Solutions:

Remove & Replace Entire Ramp.
