Intersection ID: 23977	Main Street: REA_RD	Cross Street: WINDYRUSH_RD	Location:	SE
ADA ID: DBD9CC32BD05	Ramp Type: Perp	Initial Pass/Fail: Fail	Overall Compliance: No	Severity Score: 12.5

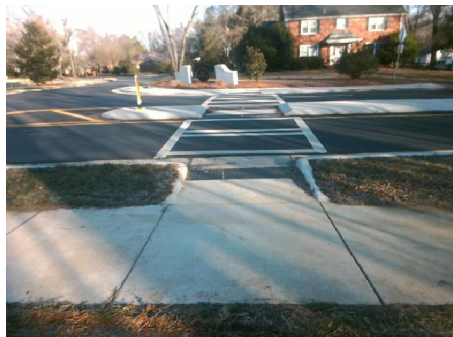
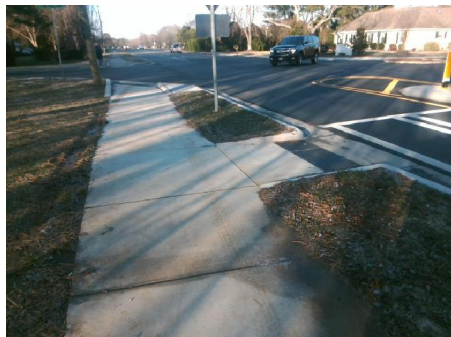
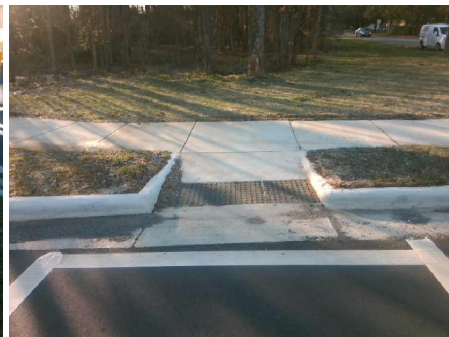
Possible Solutions:			Compliance	Description	Data	Compliance	Description	Data
Remove & Replace Entire Ramp.	N/A	Ramp Length (in)	66.0	No	Ramp Slope (%)	8.8		
	Yes	Ramp Width (in)	70.0	Yes	Ramp XSlope (%)	0.7		
	N/A	Flare Type LT	N/A	N/A	Flare Type RT	N/A		
	N/A	Flare Slope LT (%)	N/A	N/A	Flare Slope RT (%)	N/A		
	N/A	Flare Traversable LT?	N/A	N/A	Flare Traversable RT?	N/A		
	N/A	Landing Length (in)	N/A	N/A	DWS Provided?	N/A		
	N/A	Landing Width (in)	N/A	N/A	DWS Contrast?	N/A		
	N/A	Landing Slope (%)	N/A	N/A	DWS Length (in)	N/A		
	N/A	Landing X Slope (%)	N/A	N/A	DWS Full Width?	N/A		
	N/A	Landing Curb? (Y/N)	N/A	N/A	DWS Offset (in)	N/A		
Surveyor Notes: N/A	N/A	Shared Landing?	N/A					
	N/A	Gutter Ponding?	N/A	N/A	Gutter Slope (%)	N/A		
	N/A	Gutter Lip Ht (in)	N/A	N/A	Gutter X Slope (%)	N/A		
	N/A	Painted X Walk1?	Yes	N/A	Painted X Walk2?	N/A		
		X Walk 1 Direction	To N		X Walk 2 Direction	N/A		
	N/A	X Walk 1 Width (in)	115.0	N/A	X Walk 2 Width (in)	N/A

X Walk 1 Slope (%)	3.6		X Walk 2 Slope (%)	N/A		
		X Walk 1 X Slope (%)	1.5		X Walk 2 X Slope (%)	N/A		
	N/A	Ramp inside XWalk1?	Yes	N/A	Ramp inside XWalk2?	N/A		
		Road Slope (%)	N/A	N/A	Clear Space?	N/A		
PROW/ADA: R304.2.2		Road X Slope (%)	N/A	N/A	Clear Space to XWalk (in)	N/A		
	N/A	Any Obstructions?	N/A	N/A	Storm Grate/Utility Hazard?	N/A		
		Obstruction Type			Storm Grate/Utility Type			
			N/A			N/A		
				Yes	Surface Condition? (G/P)	Good		
	Total Cost:	\$	1850.00

Remove & Replace Entire Ramp.
