Access Compliance Report

Public Rights-of-Way

(Curb Ramps)

Intersection ID: 6141	Main Street: CATHEY_RD	Cross Street: ENWOOD_DR	Location: S
ADA ID: DBDA3A84CF80	Ramp Type: Perp	Initial Pass/Fail: Fail	Overall Compliance: No
Severity Score: 22.5			
Codes/Mitigation Info/Possible Solution		Field Measurements/Component Compliance

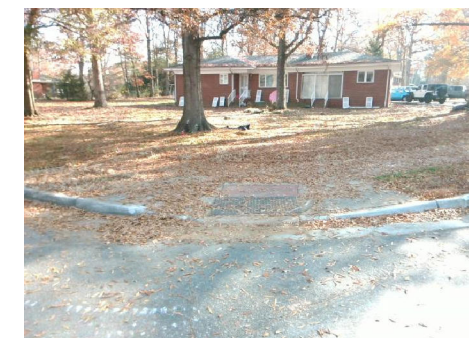
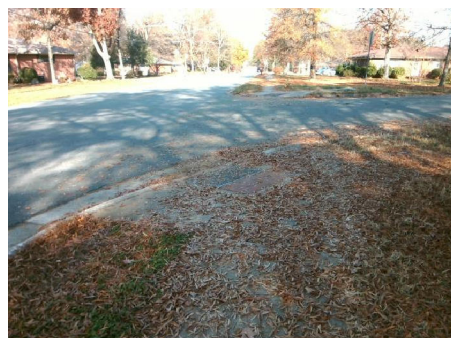
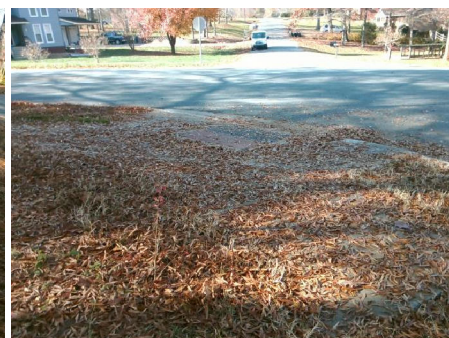
Not Found, R304.5.1, R304.2.2, R304.5.3

Compliance	Description	Data	Compliance	Description	Data
N/A	Ramp Length (in)	49.0	No	Ramp Slope (%)	8.4
No	Ramp Width (in)	47.0	No	Ramp XSlope (%)	2.7
N/A	Flare Type LT	N/A	N/A	Flare Type RT	N/A
N/A	Flare Slope LT (%)	N/A	N/A	Flare Slope RT (%)	N/A
N/A	Flare Traversable LT?	N/A	N/A	Flare Traversable RT?	N/A
N/A	Landing Length (in)	N/A	N/A	DWS Provided?	N/A
N/A	Landing Width (in)	N/A	N/A	DWS Contrast?	N/A
N/A	Landing Slope (%)	N/A	N/A	DWS Length (in)	N/A
N/A	Landing X Slope (%)	N/A	N/A	DWS Full Width?	N/A
N/A	Landing Curb? (Y/N)	N/A	N/A	DWS Offset (in)	N/A
N/A	Shared Landing?	N/A			
N/A	Gutter Ponding?	N/A	N/A	Gutter Slope (%)	N/A
N/A	Gutter Lip Ht (in)	N/A	N/A	Gutter X Slope (%)	N/A
N/A	Painted X Walk1?	No	N/A	Painted X Walk2?	N/A
	X Walk 1 Direction	To N		X Walk 2 Direction	N/A
N/A	X Walk 1 Width (in)	N/A	N/A	X Walk 2 Width (in)	N/A
	X Walk 1 Slope (%)	2.0		X Walk 2 Slope (%)	N/A
	X Walk 1 X Slope (%)	0.9		X Walk 2 X Slope (%)	N/A

N/A	Ramp inside XWalk1?	N/A	N/A	Ramp inside XWalk2?	N/A
	Road Slope (%)	N/A	N/A	Clear Space?	N/A
	Road X Slope (%)	N/A	N/A	Clear Space to XWalk (in)	N/A
N/A	Any Obstructions?	N/A	N/A	Storm Grate/Utility Hazard?	N/A
	Obstruction Type			Storm Grate/Utility Type	
		N/A			N/A
			Yes	Surface Condition? (G/P)	Good

Possible Solutions:

Remove & Replace Entire Ramp.
