# Access Compliance Report

## Public Rights-of-Way (Curb Ramps)

| Intersection ID: N/A | Main Street: MICROSOFT_WY | Cross Street: HANSON_RD | Location: S |
| ADA ID: DBDD5DD39751 | Ramp Type: Combination1Diag | Initial Pass/Fail: Pass | Overall Compliance: No |

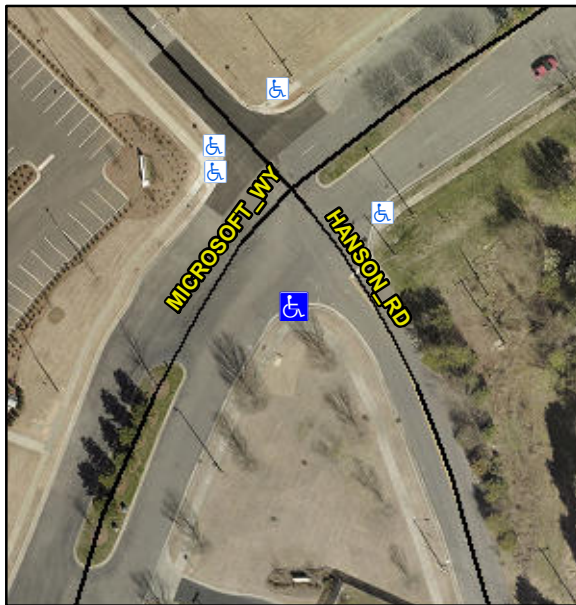
**Not Found, R304.5.3, R304.2.1, R304.2.2-Perp, R304.3.2-Para**

| Compliance | Description | Data | Compliance | Description | Data |
|---|---|---|---|---|---|
| Yes | Ramp XSlope LT (%) | 1.5 | No | Ramp XSlope RT (%) | 2.2 |
| Yes | Ramp Width (in) | 48.0 | No | Ramp XSlope (%) | 4.2 |
| No | Landing Width (in) | 47.0 | Yes | DWS Contrast? | Yes |
| No | Landing Slope (%) | 2.1 | Yes | DWS Length (in) | 24.0 |
| No | Landing X Slope (%) | 4.0 | Yes | DWS Full Width? | Yes |

**Remove & Replace Curb Ramp With Two New Directional Ramps or Equivalent.**
