# Access Compliance Report

## Public Rights-of-Way

### (Curb Ramps)

Intersection ID: N/A	Main Street: W_W_T_HARRIS_BV	Cross Street: N/A	Location: W
ADA ID: DBE095BA32BE	Ramp Type: PerpDiag	Initial Pass/Fail: Fail	Overall Compliance: No
Severity Score: 13.75			
Codes/Mitigation Info/Possible Solution		Field Measurements/Component Compliance

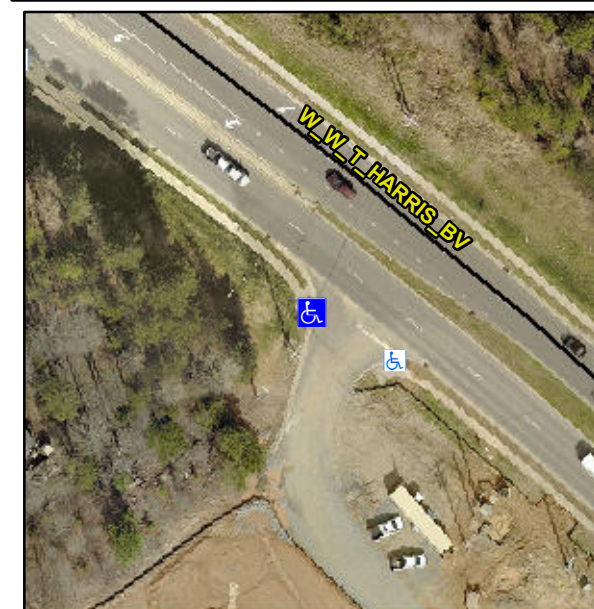
**R304.2.2, R304.5.3**

Compliance	Description	Data	Compliance	Description	Data
N/A	Ramp Length (in)	105.0	No	Ramp Slope (%)	8.5
Yes	Ramp Width (in)	48.0	No	Ramp XSlope (%)	3.3
N/A	Flare Type LT	N/A	N/A	Flare Type RT	N/A
N/A	Flare Slope LT (%)	N/A	N/A	Flare Slope RT (%)	N/A
N/A	Flare Traversable LT?	No	N/A	Flare Traversable RT?	No
N/A	Landing Length (in)	N/A	N/A	DWS Provided?	N/A
N/A	Landing Width (in)	N/A	N/A	DWS Contrast?	N/A
N/A	Landing Slope (%)	N/A	N/A	DWS Length (in)	N/A
N/A	Landing X Slope (%)	N/A	N/A	DWS Full Width?	N/A
N/A	Landing Curb? (Y/N)	N/A	N/A	DWS Offset (in)	N/A
N/A	Shared Landing?	N/A			
N/A	Gutter Ponding?	N/A	N/A	Gutter Slope (%)	N/A
N/A	Gutter Lip Ht (in)	N/A	N/A	Gutter X Slope (%)	N/A
N/A	Painted X Walk1?	No	N/A	Painted X Walk2?	No
	X Walk 1 Direction	To SE		X Walk 2 Direction	To NE
N/A	X Walk 1 Width (in)	N/A	N/A	X Walk 2 Width (in)	N/A
	X Walk 1 Slope (%)	1.3		X Walk 2 Slope (%)	4.3
	X Walk 1 X Slope (%)	4.1		X Walk 2 X Slope (%)	0.9

N/A	Ramp inside XWalk1?	N/A	N/A	Ramp inside XWalk2?	N/A
	Road Slope (%)	2.2	N/A	Clear Space?	N/A
	Road X Slope (%)	3.6	N/A	Clear Space to XWalk (in)	N/A
N/A	Any Obstructions?	N/A	N/A	Storm Grate/Utility Hazard?	N/A
	Obstruction Type			Storm Grate/Utility Type	
		N/A			N/A
			Yes	Surface Condition? (G/P)	Good

**Remove & Replace Curb Ramp With Two New Directional Ramps or Equivalent.**

Total Cost: \$ 3200.00
