Access Compliance Report

Public Rights-of-Way

(Curb Ramps)

Intersection ID: 20986	Main Street: W_ARROWWOOD_RD	Cross Street: ARROWPOINT_BV	Location:	N
ADA ID: DBE1048BA071	Ramp Type: MedianPerp	Initial Pass/Fail: Fail	Overall Compliance: No	Severity Score: 12.5
Codes/Mitigation Info/Possible Solution		Field Measurements/Component Compliance

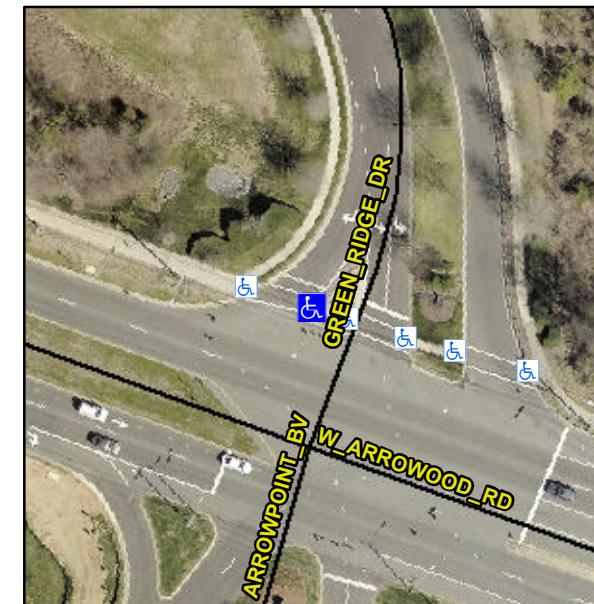
Compliance	Description	Data	Compliance	Description	Data
N/A	Ramp Length (in)	53.0	No	Ramp Slope (%)	9.4
Yes	Ramp Width (in)	48.0	Yes	Ramp XSlope (%)	2.0
N/A	Flare Type LT	N/A	N/A	Flare Type RT	N/A
N/A	Flare Slope LT (%)	N/A	N/A	Flare Slope RT (%)	N/A
N/A	Flare Traversable LT?	N/A	N/A	Flare Traversable RT?	N/A
N/A	Landing Length (in)	N/A	N/A	DWS Provided?	N/A
N/A	Landing Width (in)	N/A	N/A	DWS Contrast?	N/A
N/A	Landing Slope (%)	N/A	N/A	DWS Length (in)	N/A
N/A	Landing X Slope (%)	N/A	N/A	DWS Full Width?	N/A
N/A	Landing Curb? (Y/N)	N/A	N/A	DWS Offset (in)	N/A
N/A	Shared Landing?	N/A			
N/A	Gutter Ponding?	N/A	N/A	Gutter Slope (%)	N/A
N/A	Gutter Lip Ht (in)	N/A	N/A	Gutter X Slope (%)	N/A
N/A	Painted X Walk1?	Yes	N/A	Painted X Walk2?	N/A
	X Walk 1 Direction	To NW		X Walk 2 Direction	N/A
N/A	X Walk 1 Width (in)	96.0	N/A	X Walk 2 Width (in)	N/A
	X Walk 1 Slope (%)	1.1		X Walk 2 Slope (%)	N/A
	X Walk 1 X Slope (%)	0.2		X Walk 2 X Slope (%)	N/A

N/A	Ramp inside XWalk1?	Yes	N/A	Ramp inside XWalk2?	N/A
	Road Slope (%)	N/A	N/A	Clear Space?	N/A
	Road X Slope (%)	N/A	N/A	Clear Space to XWalk (in)	N/A
N/A	Any Obstructions?	N/A	N/A	Storm Grate/Utility Hazard?	N/A
	Obstruction Type			Storm Grate/Utility Type	
		N/A			N/A
			Yes	Surface Condition? (G/P)	Good

Possible Solutions:

Remove & Replace Entire Ramp.

R304.2.2
